# **REPORT OF APOLLO 13 REVIEW BOARD**

**APPENDIX B - REPORT OF MISSION  
EVENTS PANEL**

**APPENDIX C - REPORT OF MANUFACTURING  
AND TEST PANEL**

**APPENDIX D - REPORT OF DESIGN PANEL**

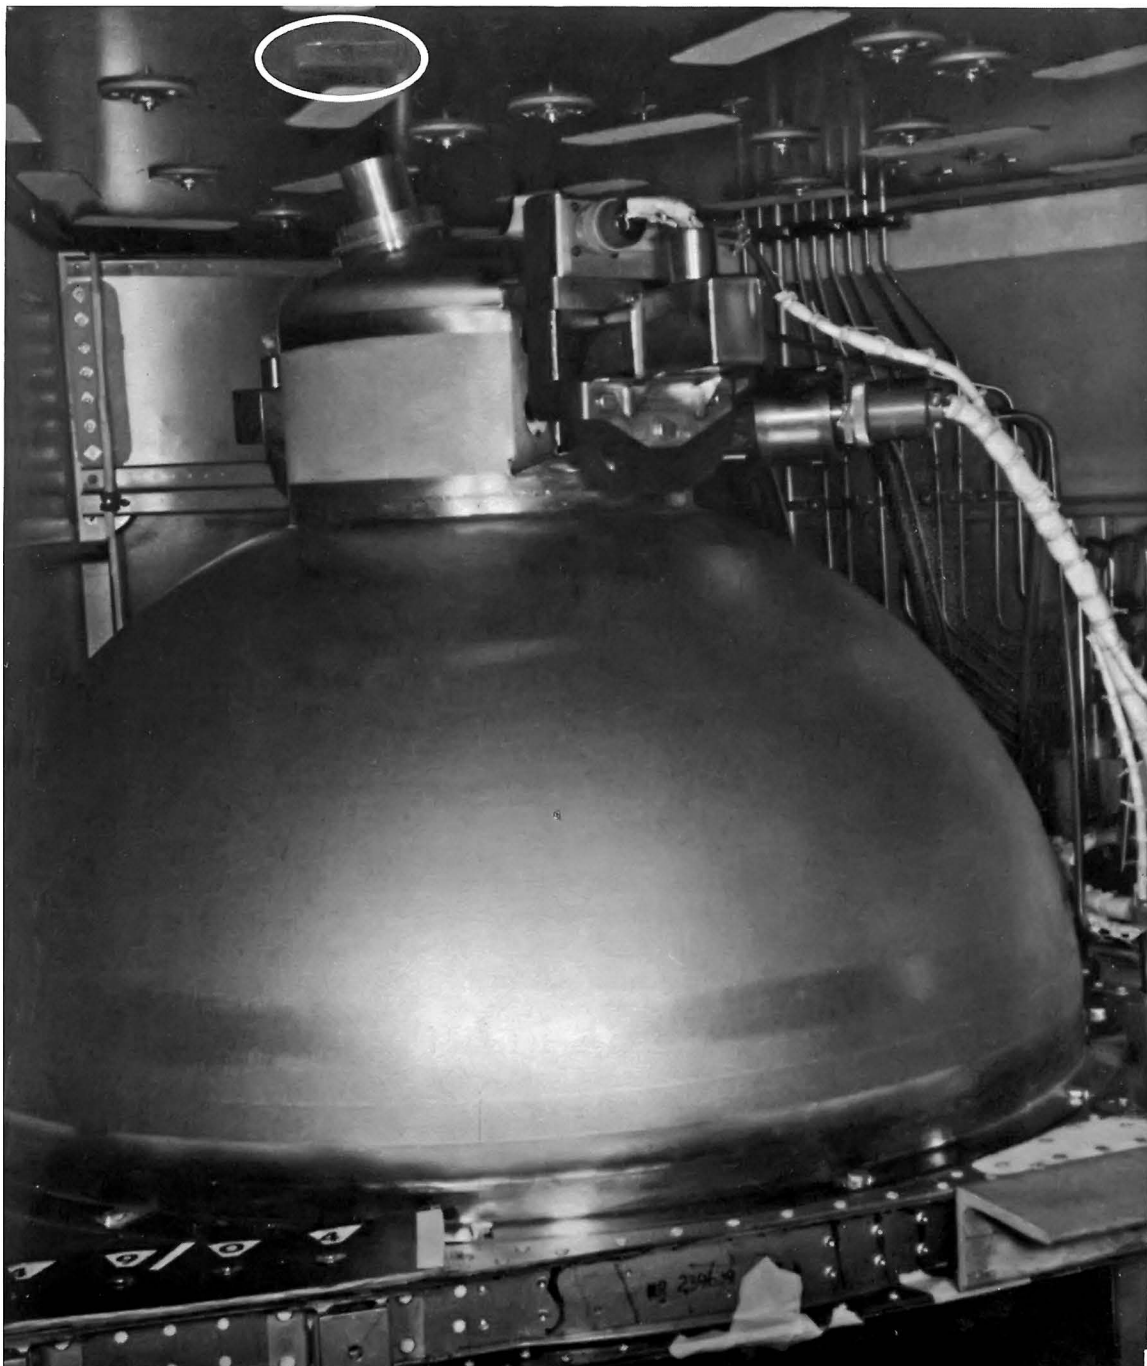
Figure C4-54.- Replacement oxygen shelf installed in Service Module 106. Note repairs to fuel cell shelf over oxygen tank no. 2.

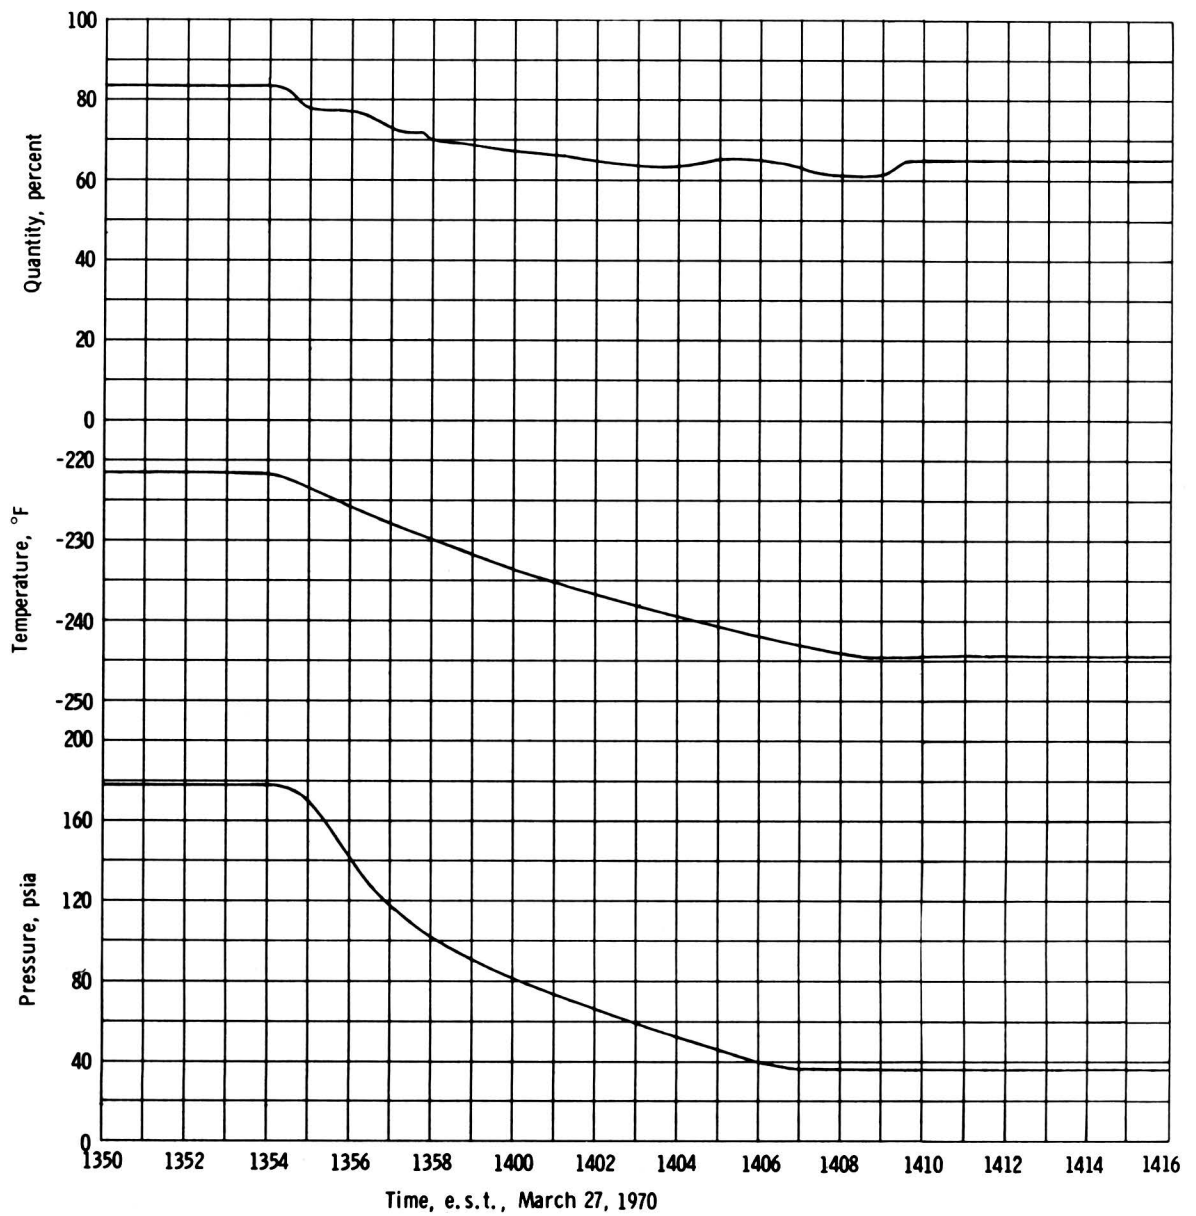
Figure C4-58.- Oxygen tank 2 detanking characteristics (pressure decay through the fill line - CDDT).

During the countdown, April 8, 1970, the pressurization of oxygen tank no. 2 was hampered by a leak through the vent line pressure-operated disconnect. Installation of the first cap stopped the leak and the pressurization of tank no. 2 was normal with no anomalies noticed during the completion of the countdown.

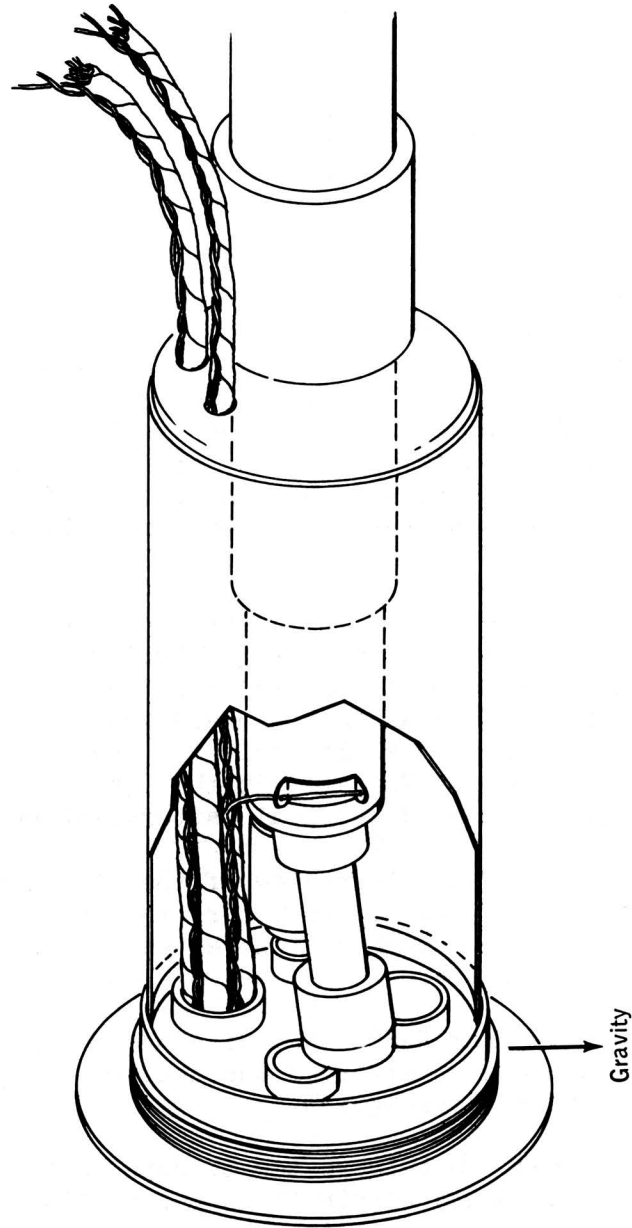
Figure C4-64.- Isometric sketch of quantity probe head as oriented during SM transportation.

It appears pertinent to this review to note that during SM transportation the fill tube segments within the upper portion of the oxygen tank no. 2 quantity probe assembly lay with the tank-exit end of the fill tube segments about 20 degrees above the horizontal, if they were still in place after previous handling and the "shelf drop." Neither the wires nor the feed line filter were below it to restrict rotation of the fill tube about the central tube of the quantity probe (fig. C4-64).

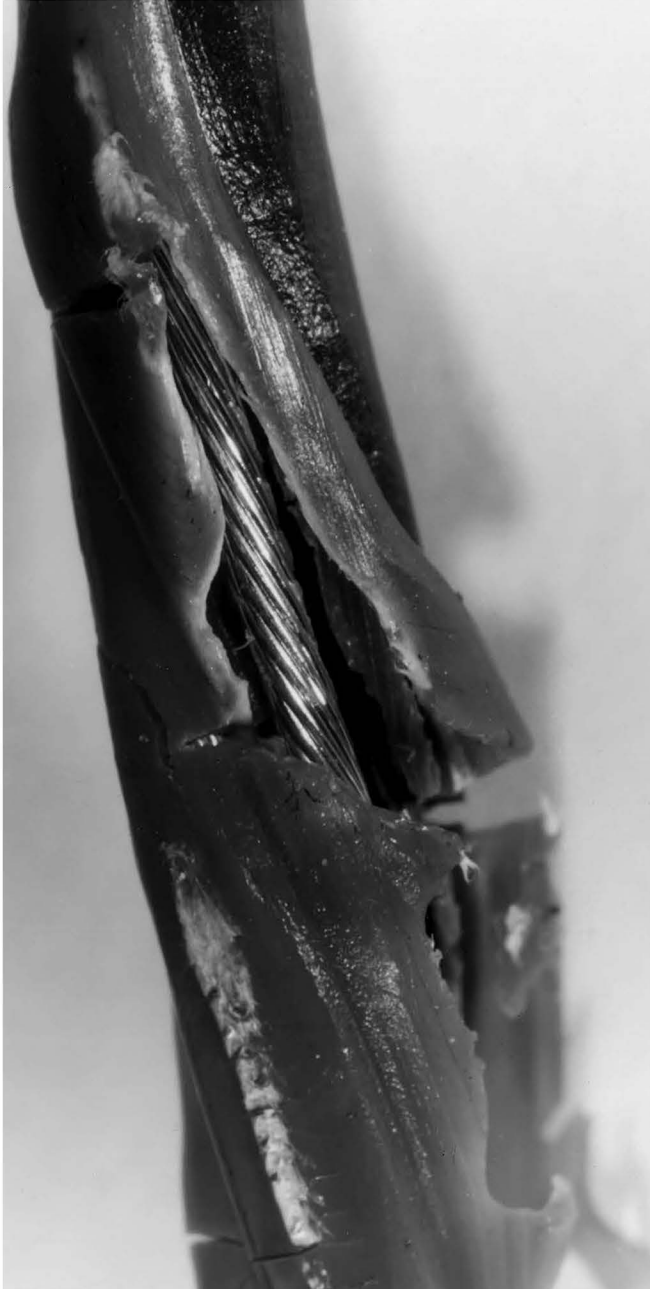
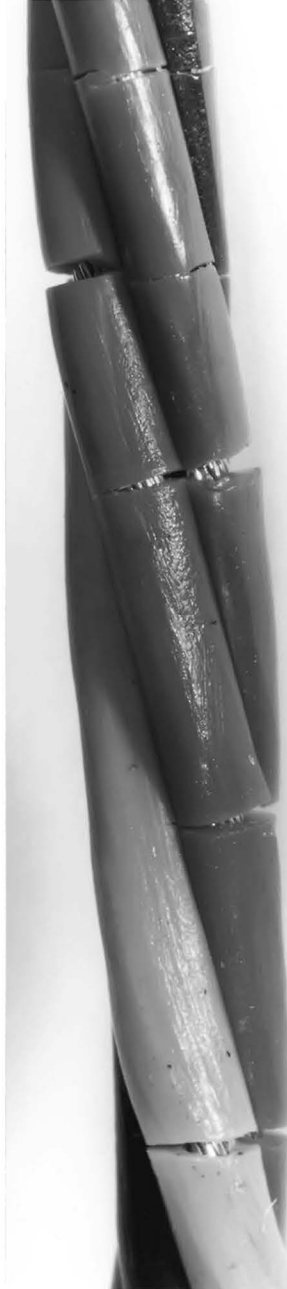
Figure C4-68.- Wire damage from heater tube assembly temperature test.

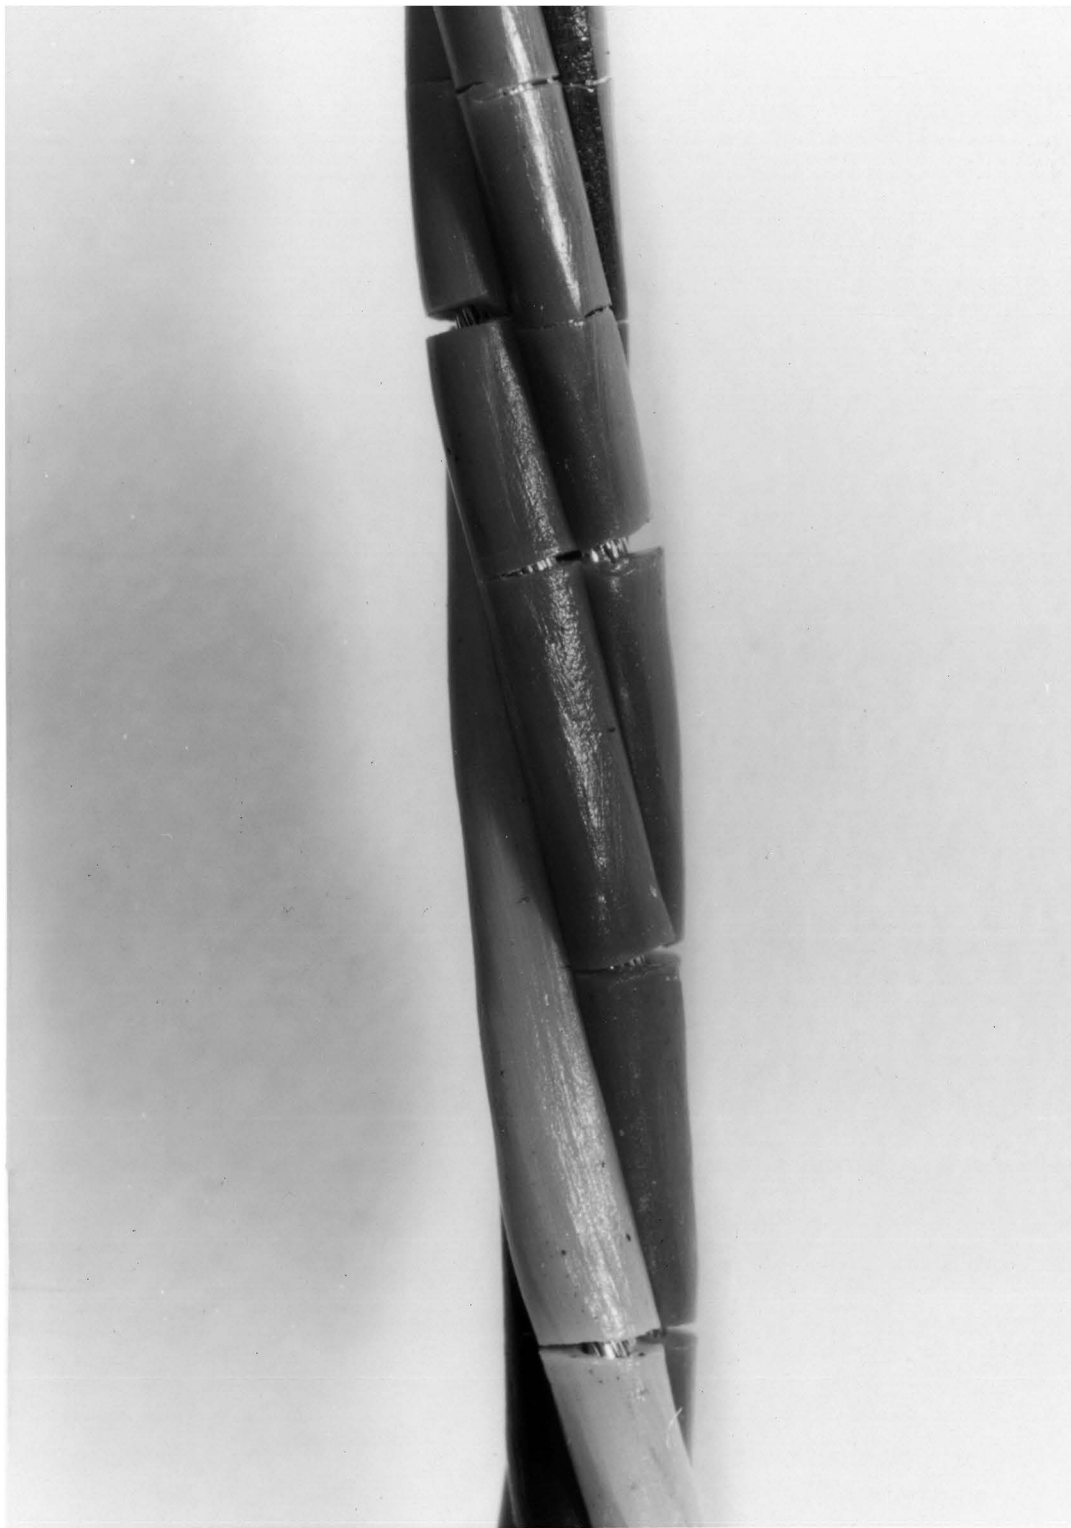
Figure D3-24.- Photograph of wire damage.
