# **REPORT OF APOLLO 13 REVIEW BOARD**

**APPENDIX B - REPORT OF MISSION  
EVENTS PANEL**

**APPENDIX C - REPORT OF MANUFACTURING  
AND TEST PANEL**

**APPENDIX D - REPORT OF DESIGN PANEL**

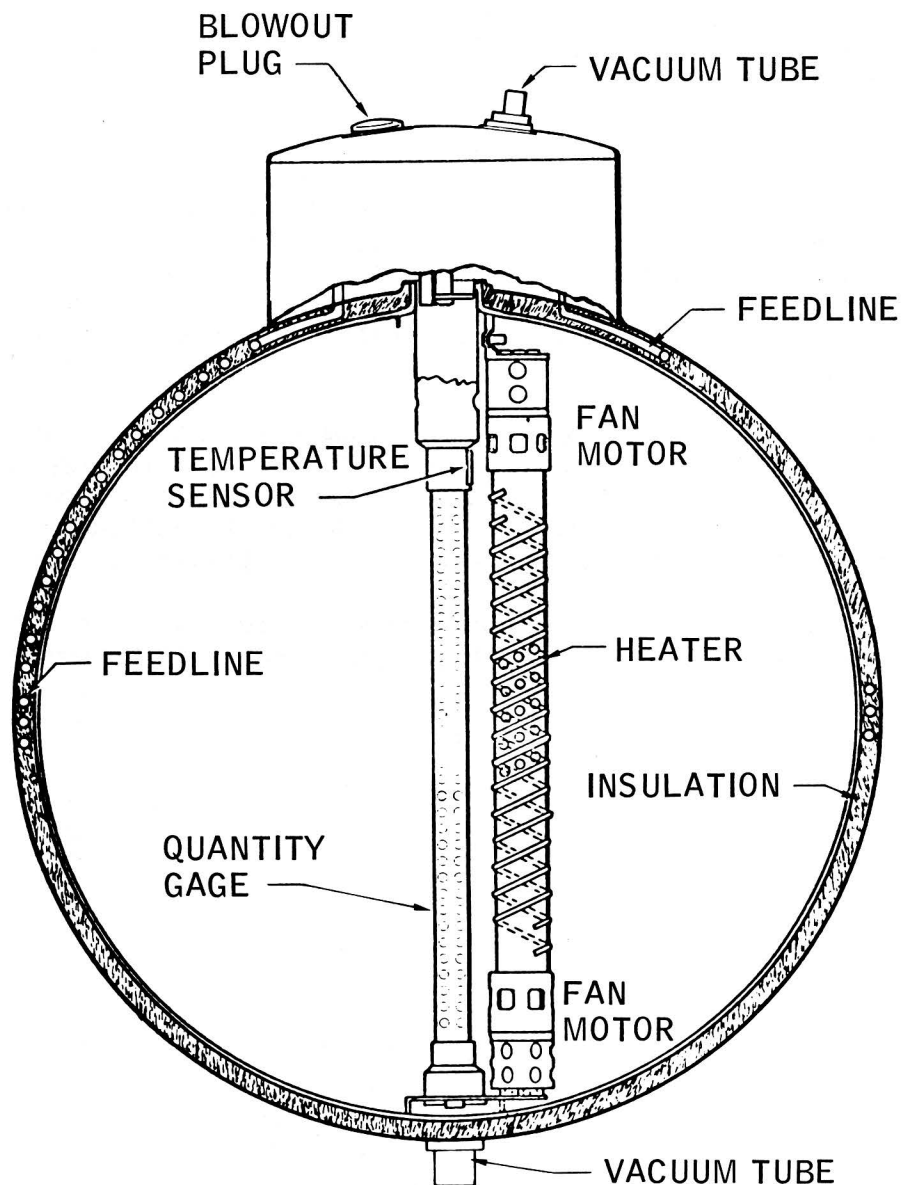
Figure B4-11.- Arrangement of components within oxygen tank.

At 47:40:08 the oxygen quantity changed from approximately 82 percent to 100 percent, or full-scale high. This change in reading or quantity system malfunction occurred just after or at the time the oxygen tank no. 2 fans were turned on. Because of the way the system recovered at the time of the accident, the data indicate that the probe or its associated wiring shorted. Since the instrumentation system was in low bit rate, it is possible to determine exactly when the oxygen

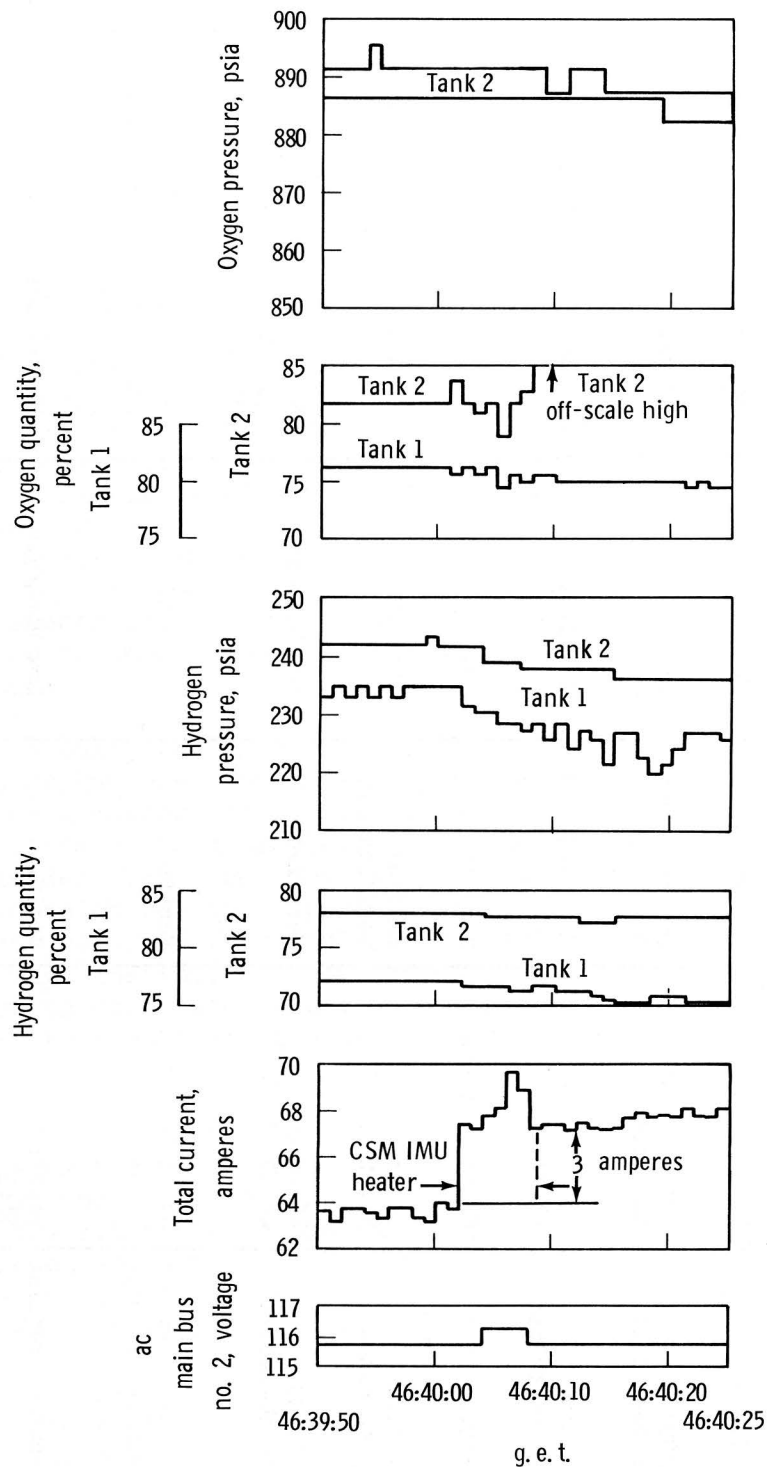
Figure B4-12.- Fan cycle at 46:40.

tank no. 1 and no. 2 fans were turned on. The electrical data indicate that the oxygen tank no. 1 and no. 2 fans were turned on between the times of 47:40:05 and 47:40:08. A plot of cryogenic pressures, quantities, total CSM current, and ac main bus 2 is shown in figure B4-12. Therefore, the oxygen tank no. 1 and no. 2 fans were turned on in a period of time between 3 seconds prior to the probe malfunction and the time that the probe malfunctioned.

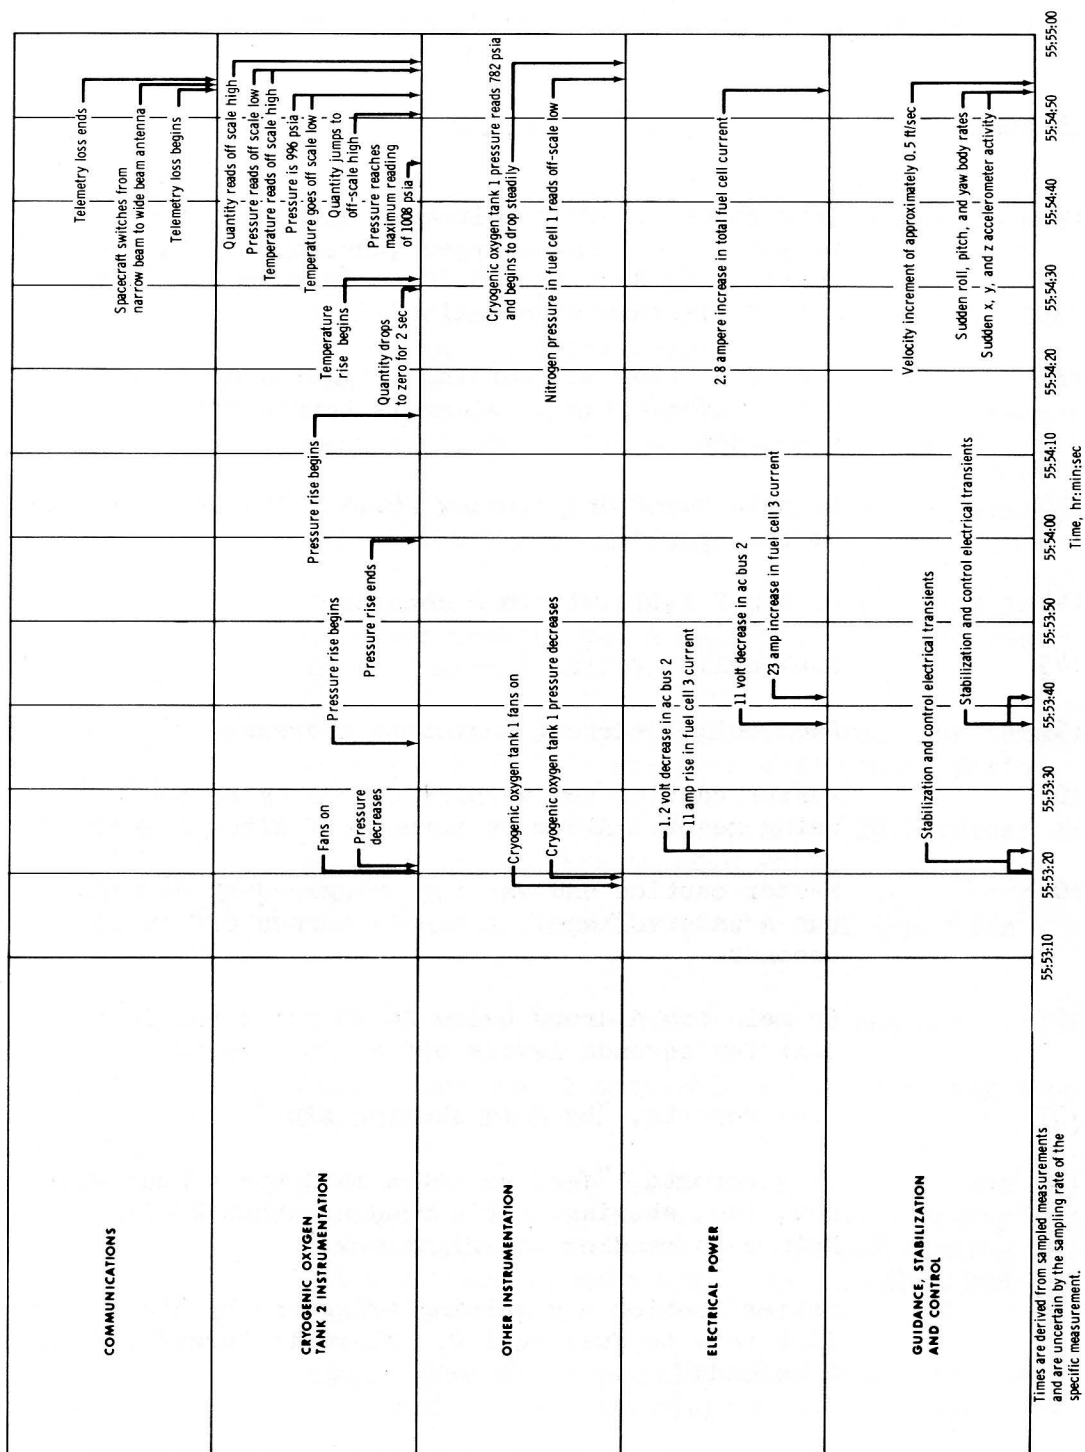
Figure B5-1.- Sequence of events immediately preceding the accident.

<u>Time, g.e.t.</u>	<u>Event</u>
Events During 52 Seconds Prior to First Observed Abnormality	
55:52:31	Master caution and warning triggered by low hydrogen pressure in tank no. 1. Alarm is turned off after 4 seconds.

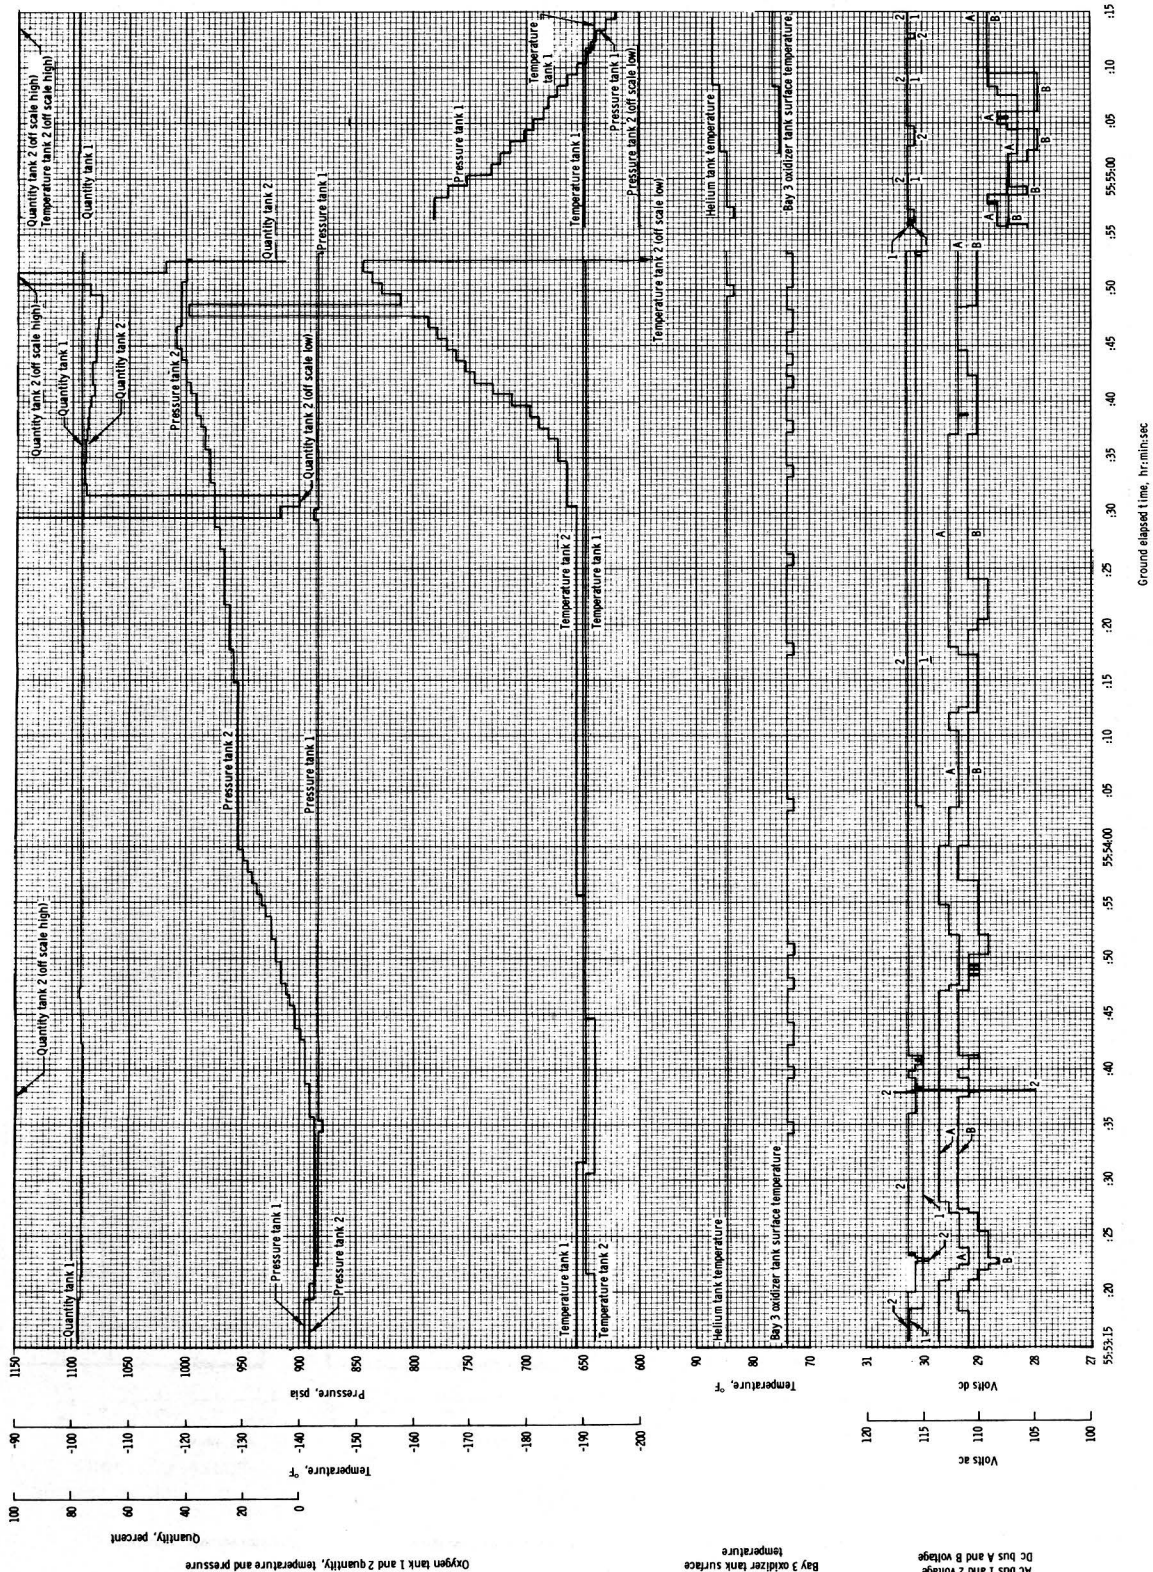
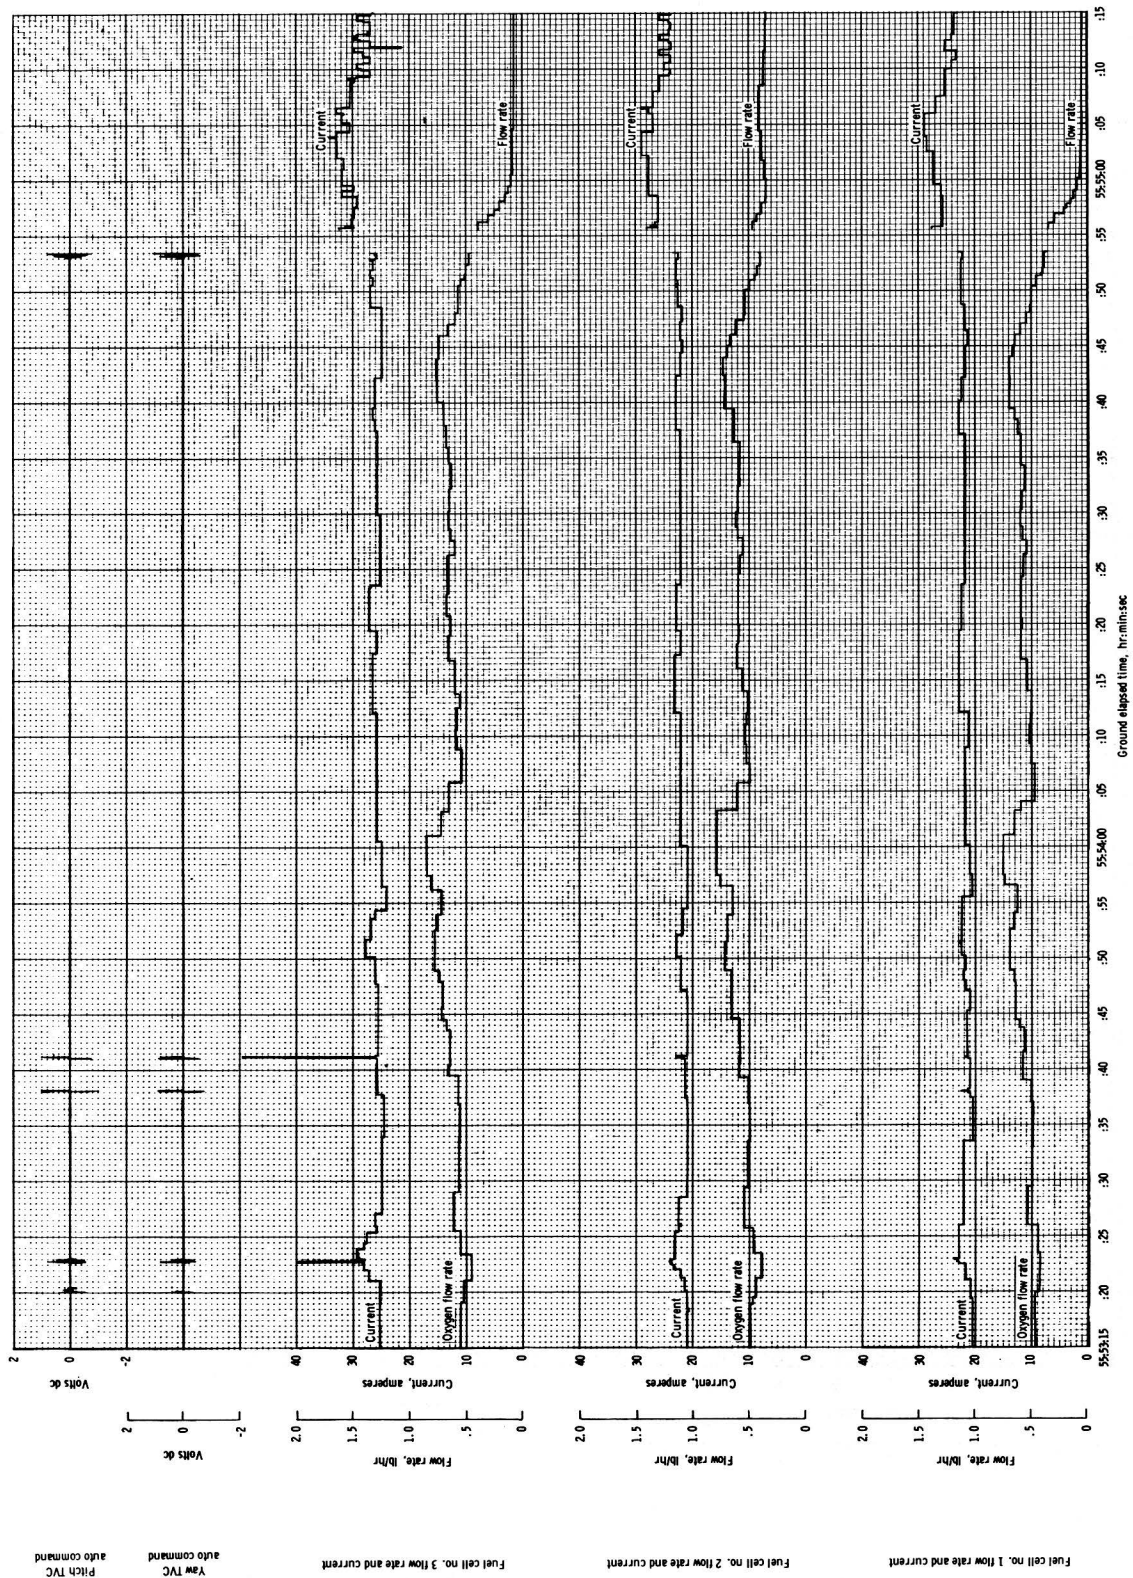
Figure B5-3(a).-- Telemetered parameters during anomaly.

At 55:53:18 when the two fans in cryogenic oxygen tank no. 1 were turned on by the crew, a drop in ac bus 1 voltage (fig. B5-3) and an increase of 1 ampere in total command module current indicated that the fans had been electrically energized. (Total command module current, plotted in figure B5-4, is obtained by adding the current outputs of all three fuel cells and subtracting the current drain of the lunar module.) A subsequent decrease in tank pressure and oscillations in the fuel cell flowmeters indicated that the fans had begun to stir the oxygen (fig. B5-3).

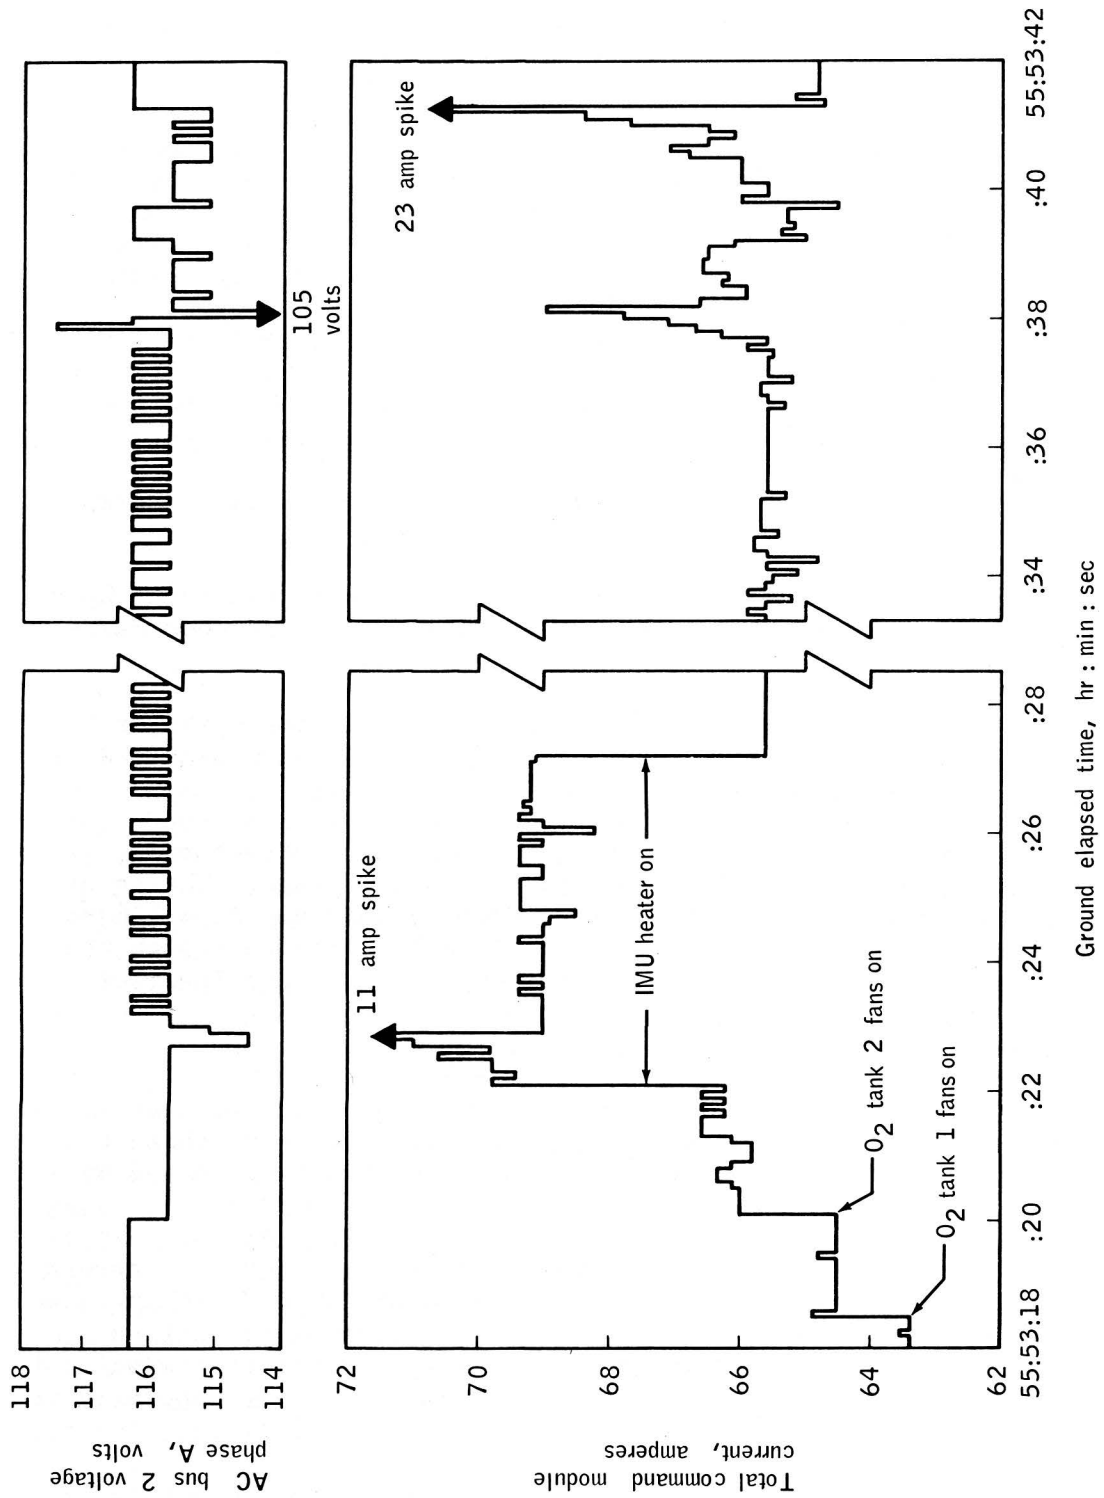
Figure B5-4.- Electrical anomalies.

voltage of 0.6 volt, and a glitch in the stabilization control system telemetry indicated that the fans had been electrically energized. These events are shown in figures B5-4 and B5-5. However, it is not certain that the fans began rotating at this time, since the tank no. 2 pressure showed a minimum observable drop and the fan motor stall current does not significantly differ from the running current. The quantity gage in tank no. 2 was already in a failed condition, and the fuel cell flowmeters were already being affected by the fan operation in tank no. 1, so that neither of these instruments could positively verify rotation of the fans in tank no. 2. During the next 20 seconds a series of electrical anomalies occurred which cannot be explained as a result of known loads in the spacecraft. These anomalies are shown in figure B5-4. The first, at 55:53:23 was an 11-amp positive spike in the output current of fuel cell 3. Several events were associated with this spike:

The most probable cause of the electrical disturbances between 55:53:22 and 55:53:42 is that a short circuit occurred in the electrical

system of the cryogenic oxygen tank no. 2 fans. The short circuit was sufficiently severe to result in loss of part of the fan load at 55:53:22 and the remainder at 55:53:41. Reduction of the load could have been caused by fuses blowing or by wires opening.

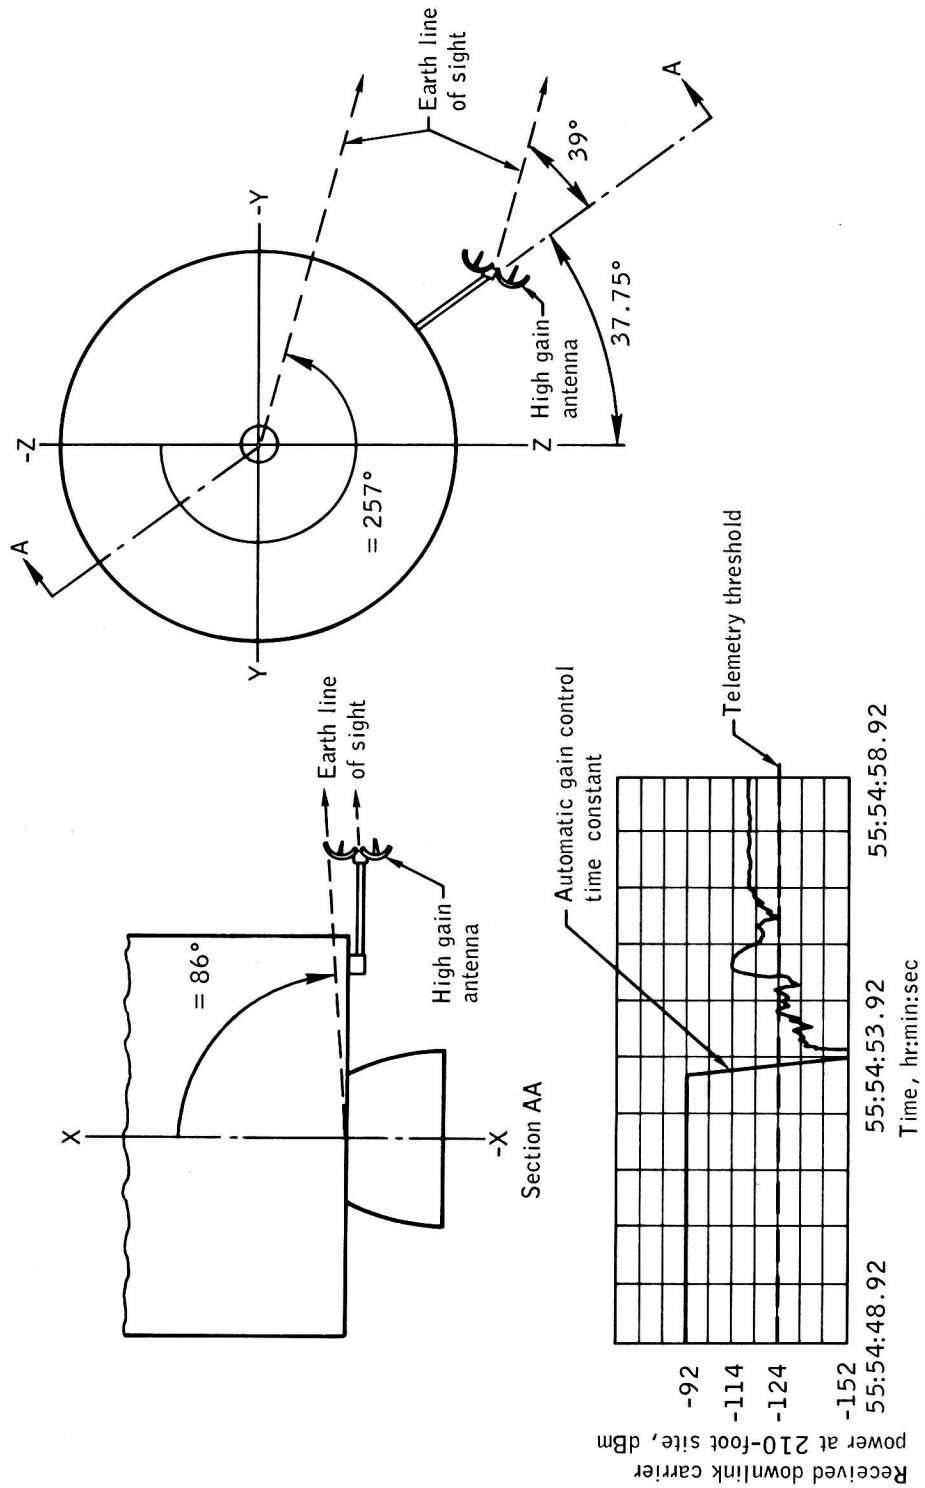
Figure B5-6.- Received S-band downlink power.

At the time of the accident the spacecraft telemetry signal was being received on both a 210-ft-diameter and an 85-ft-diameter antenna at the Deep Space Instrumentation Facility in Goldstone, California. The carrier level on the Goldstone 85-ft antenna was -100 dBm. At 55:54:53 the signal strength dropped abruptly below -160 dBm, the lower limit of the signal strength recorder, and began an erratic increase. Figure B5-6 is a plot of the carrier strength received at the 85-ft antenna, corrected by 8 dB to show the carrier strength received at the 210-ft antenna. The 210-ft antenna was not equipped with a signal strength recorder.

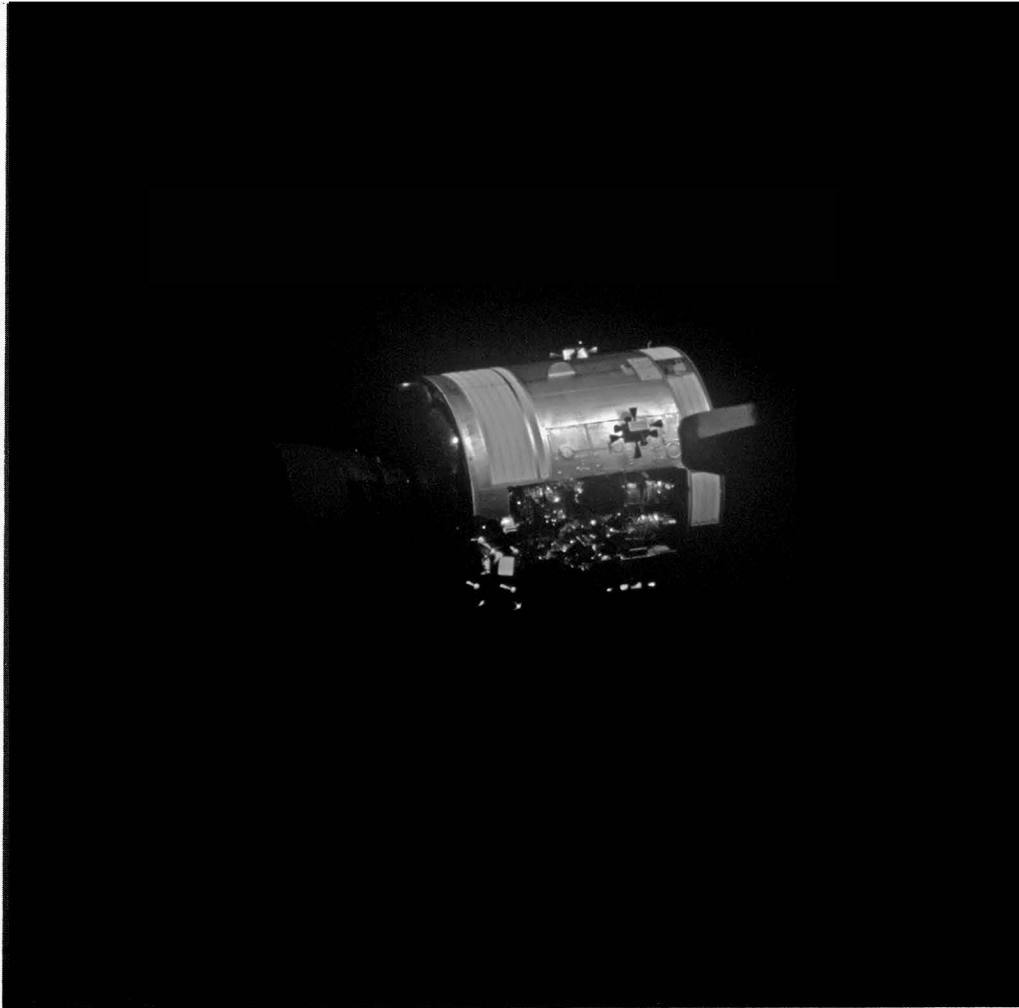
Figure B5-9.- Photograph of service module taken by crew.

Photographs later taken by the crew show the panel covering bay 4, the bay containing the cryogenic oxygen tanks, cryogenic hydrogen tanks, and fuel cells, to be missing. One of these photographs is reproduced in figure B5-9 and a photograph prior to launch is shown in figure B5-10. The high-gain antenna located adjacent to bay 4 shows a misalignment of one of the four dishes. The photographs also show that the axes of fuel cells 1 and 3 have shifted 7 degrees in such a way that the tops of the fuel cells point outward. It is not possible to determine conclusively from the photographs whether or not cryogenic oxygen tank no. 2 is present, partially missing, or totally missing. It is probable that the loud bang heard by the crew was caused by the separation of the panel from the spacecraft approximately at the time of telemetry loss.

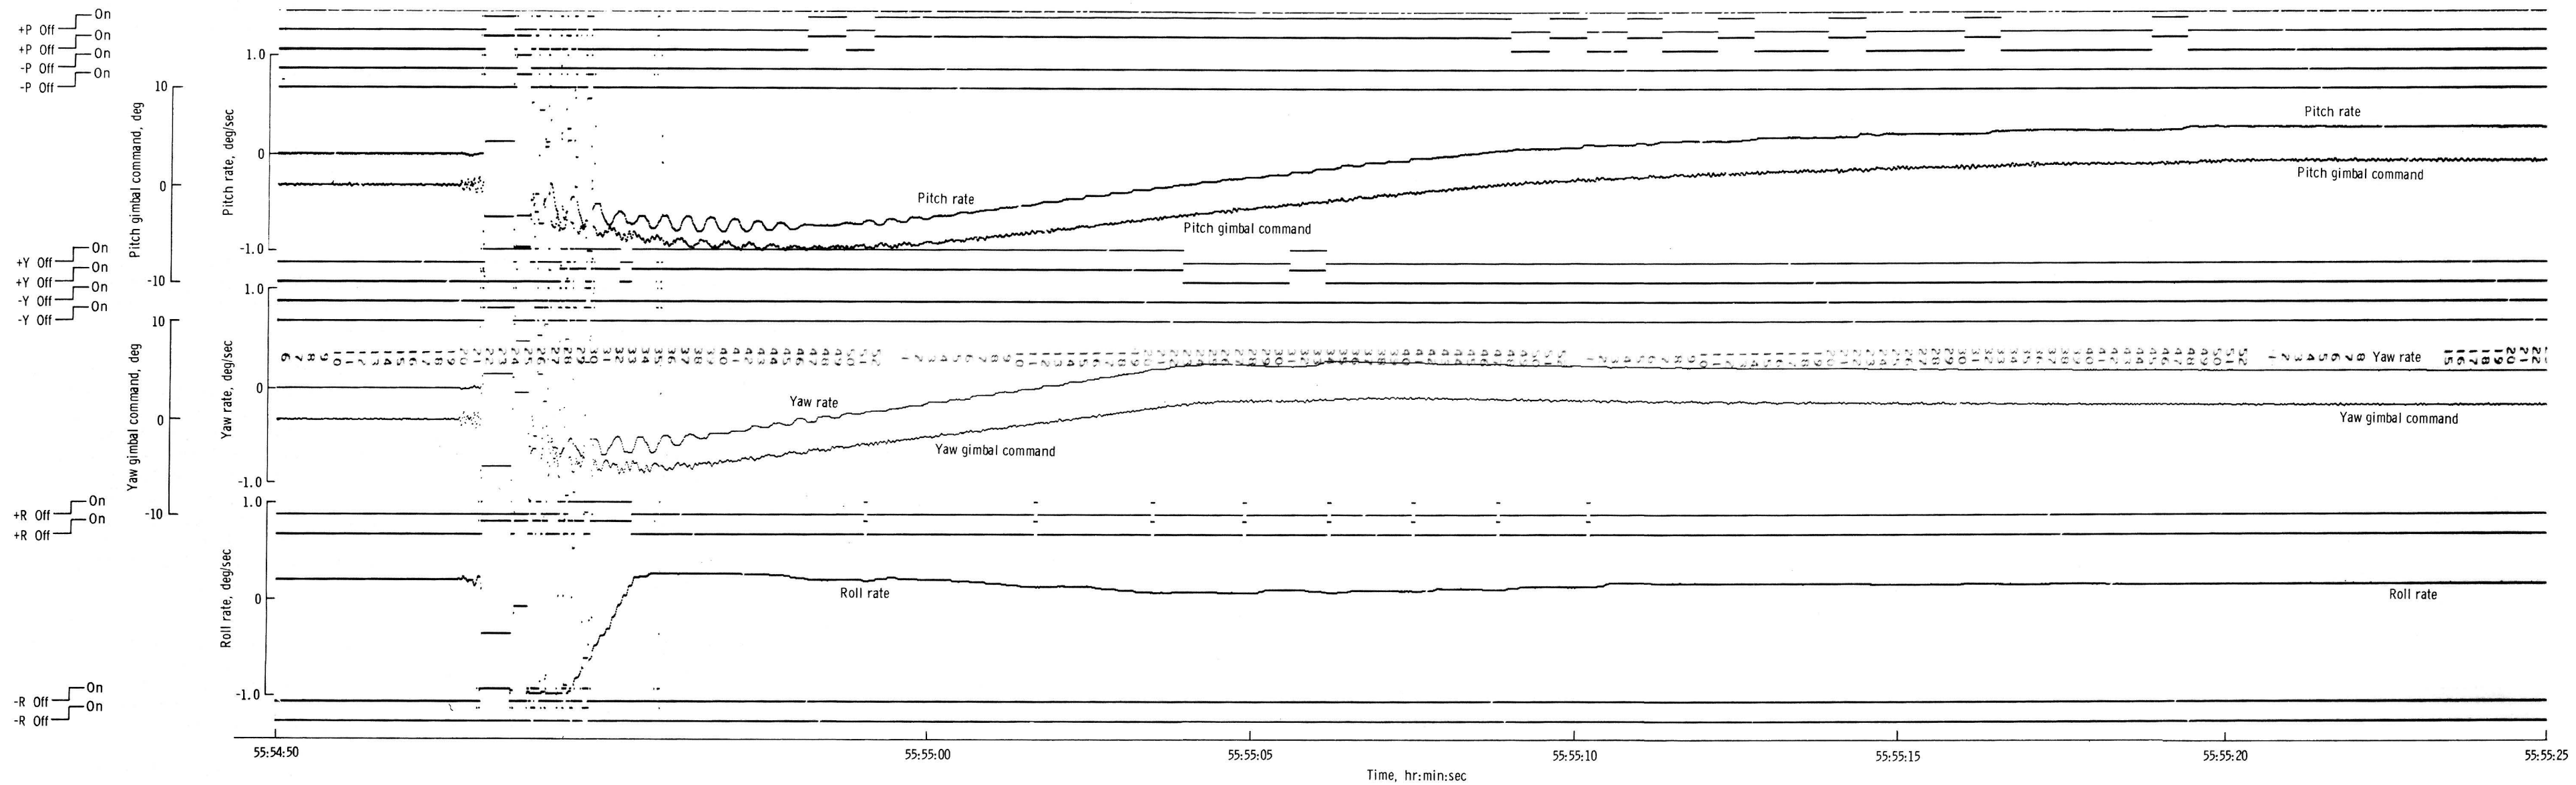
Figure B5-11.- Roll, pitch, and yaw rates.

The roll, pitch, and yaw rates were automatically compensated for by the attitude control system, as shown in figure B5-11.

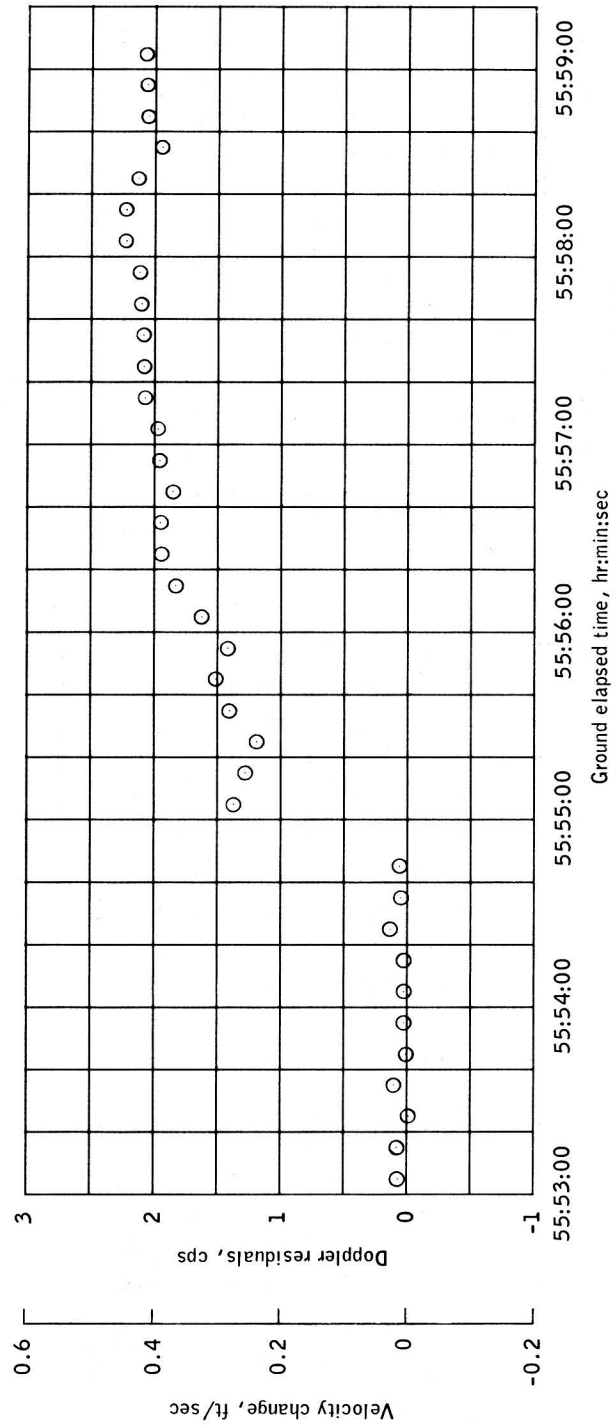
Figure B5-12.- Velocity increment at 55:54:53.

Between 55:54:45 and 55:55:05 doppler measurements indicated a radial velocity increment of 0.26 fps. This is shown in figure B5-12. Following this abrupt change in velocity at approximately the time of telemetry loss, additional velocity changes were observed, as shown in figure B5-13. These velocity increments were caused in part by venting from the spacecraft and in part by firings of reaction control system jets.

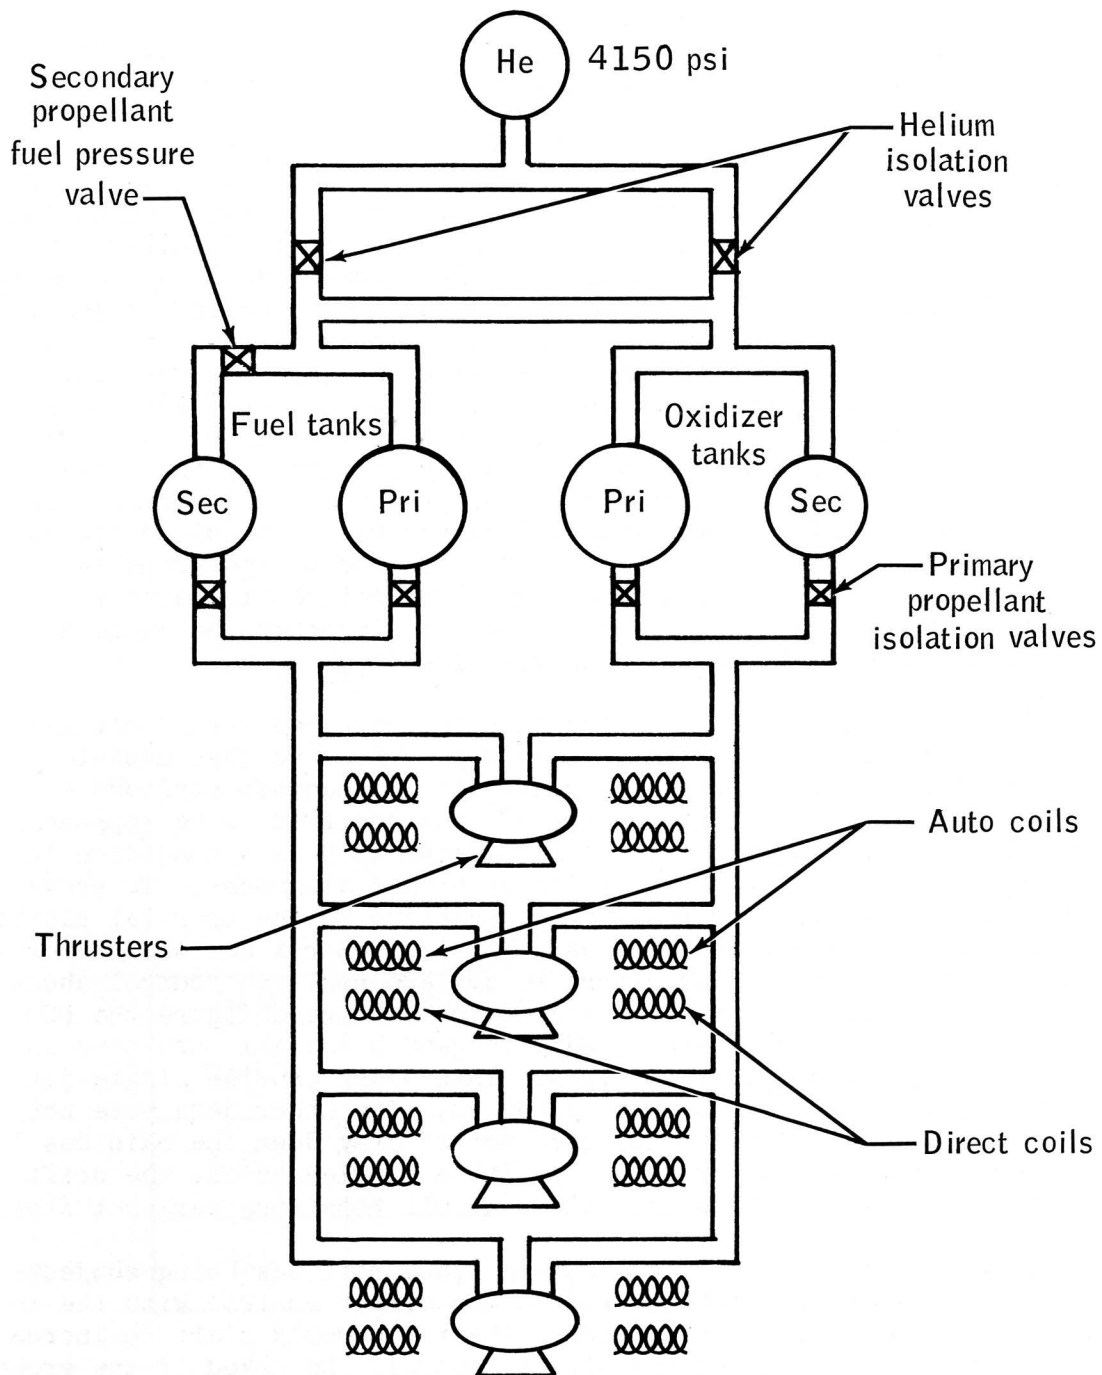
Figure B6-1.- Service module reaction control system one quad (typical of all four).

The valve position indicators in the spacecraft are the flag type which show gray when the valve is open and gray-and-white stripe ("barberpole") when closed; there is no telemetry indication of the valve position. Each valve and its respective indicator are powered from the same main dc bus and cannot be selected to the other bus. The valves in the propellant system for quads B and D are powered from main bus A and quads A and C are powered from main bus B. Therefore, there was no way to determine the status of the RCS propellant and pressurization systems of quads A and C, and there was no way to reposition the valves without powering up main bus B. The ability to open the isolation valves in quads B and D was not affected by the loss of main bus B.

Jet-firing signals, received at each individual thruster, open fuel and oxidizer valves by energizing a coil. There are two coils at each thruster. One, called "Auto," receives its signal from either the computer or the two rotational hand controllers (RHC's) and can be powered from either main dc bus, selected by the "Auto RCS Select" switches. There are 16 switches; one for each individual thruster that can be positioned to "off," "main A," or "main B." The other coil at the thruster is called "Direct" and receives its signal from the rotational hand controllers when they are rotated sufficiently far from the null detent. There are several ways of configuring the RHC's to power the Direct coils. Each RHC is limited as to which main bus and thruster combination it can be tied. Typically, the RHC's are powered so that half the jets are fired by main bus B and the other half by main bus A. As per normal procedure, the auto RCS select switches were configured so that single-jet authority in roll, pitch, and yaw attitude control would be available without reconfiguring if either main bus were lost. This protection can only be obtained if all four quads are functional. The loss of capability resulting from the failure of a main bus would be compounded by the concurrent closing of propellant isolation valves. Control about one or more axes would be lost

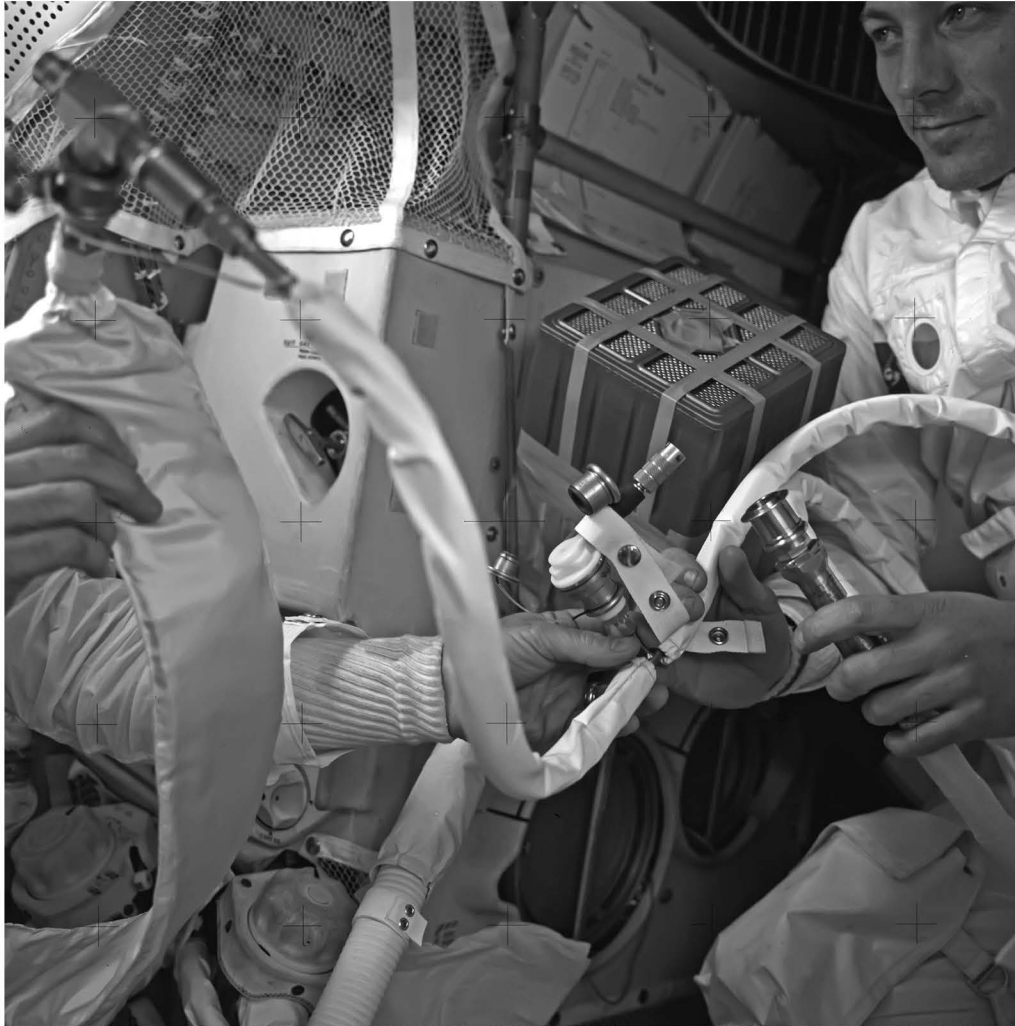
Figure B6-7.- View of CM LiOH cannister modification as installed in the LM.

The problem of removing carbon dioxide from the cabin oxygen was a serious one. The LM, like the CSM, uses lithium hydroxide (LiOH) cartridges to scrub the recirculated oxygen to remove odors and carbon dioxide. The LiOH cartridges are rated for a specified total man-hours capacity, and eventually must be replaced when they become saturated. The LM cartridges were not adequate for carbon dioxide removal for three men for the duration of the Earth-return trip. There were more than adequate cartridges in the CM, but they would not fit in the LM canisters. There were several methods suggested for solving the problem, including powering up the CM system to circulate cabin oxygen through its LiOH canisters. The method that was actually used was developed by Crew Systems Division personnel at MSC. It consisted of using tape, flight data file cards, and plastic bag material to connect the CM LiOH canisters to the LM oxygen circulation system. The crew implemented the modification and it worked very well. The partial pressure of carbon dioxide reading indicated by the onboard gage dropped rapidly from 8mm Hg to 0.1mm Hg soon after the rig was completed at 94 hours g.e.t. The modification was not tried until this time in order to get maximum use from the LM cartridges. About 20 hours later, the carbon dioxide partial pressure reading had increased to 1.8mm Hg, and a procedure for putting two additional cartridges in series to those in the CM canisters was given to the crew. This procedure was also developed by engineers at MSC (fig. B6-7). After this second modification was completed, the carbon dioxide partial pressure remained below 2mm Hg for the rest of the mission, without any further modifications necessary.

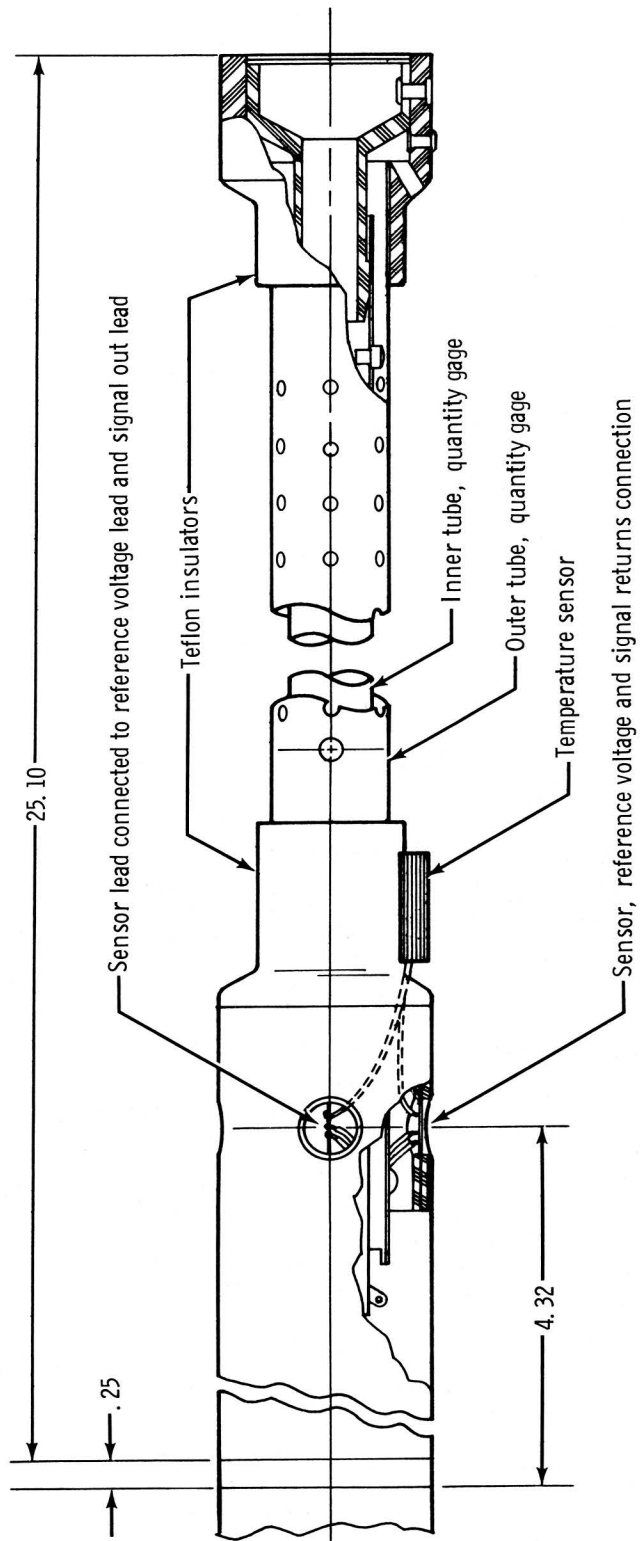
Figure B7-1. - Oxygen quantity gage and temperature sensor location.

The quantity gage read full-scale high after telemetry recovery and continued in this state until 55:56:38 when it began oscillating in an erratic manner. The oscillation continued until 55:57:47 when the gage assumed an off-scale-low reading. The quantity gage and its failure modes are described in Part B7 of this Appendix.

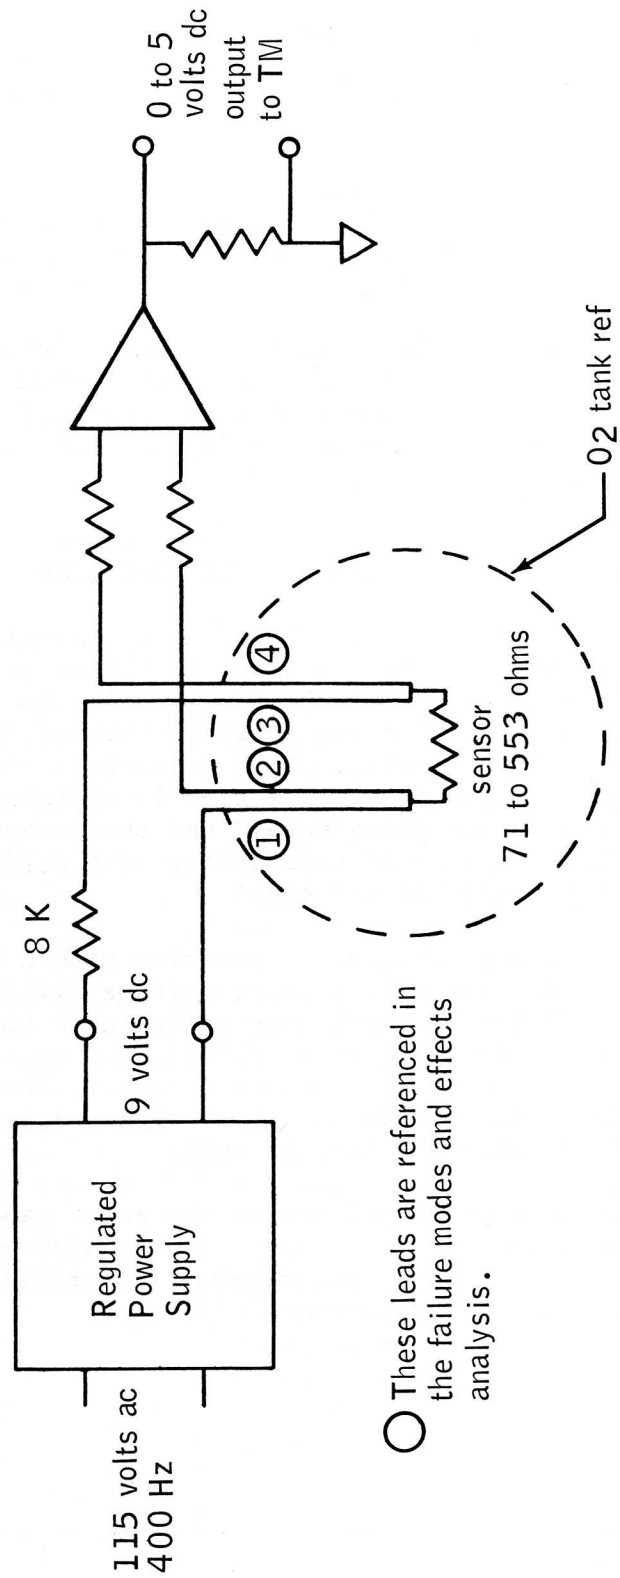
Figure B7-2.- Oxygen tank temperatures sensing circuit.

when it began a steady decrease which ended at 55:56:48 in an off-scale-low reading. This behavior is a possible result of a failure of the sensor. For an explanation of possible failure modes of this sensor, see Part B7 of this Appendix. The pressure of cryogenic oxygen tank no. 2, sensed remotely, read off-scale low and continued to show this reading. Off-scale low for this sensor represents a pressure of 19 psia or below.

Failure mode	Indication	Resulting damage
Any of the four temperature sensor leads shorted to 115 V ac line (1, 2, 3, 4)	Full scale output followed by zero output	Would fail signal conditioner amplifier, sensor element, and pulse code modulation gate
Temperature sensor shorted to the density probe element	*No change in output	Probably no circuit element damage
Temperature sensor shorted to ground (either side)	*Zero output signal	No circuit damage
Dc power shorted to temperature sensor	Full scale output	Would fail signal conditioner output
Either or both sensor leads open	Full scale output	None
400 Hz power input to power supply disconnected.	Output drifts to zero as charge in power supply filter capacitors discharge.	None
Temperature sensor leads shorted to each other	*Zero output	None
Any one of leads 1, 3, or 4 broken (open) (fig. B7-2)	Zero output	No circuit damage
Open lead 2 (fig. B7-1)	*Immediate rise to full scale followed by a linear decay to zero in approx. 10 msec	No circuit damage
