# **REPORT OF APOLLO 13 REVIEW BOARD**

**APPENDIX B - REPORT OF MISSION  
EVENTS PANEL**

**APPENDIX C - REPORT OF MANUFACTURING  
AND TEST PANEL**

**APPENDIX D - REPORT OF DESIGN PANEL**

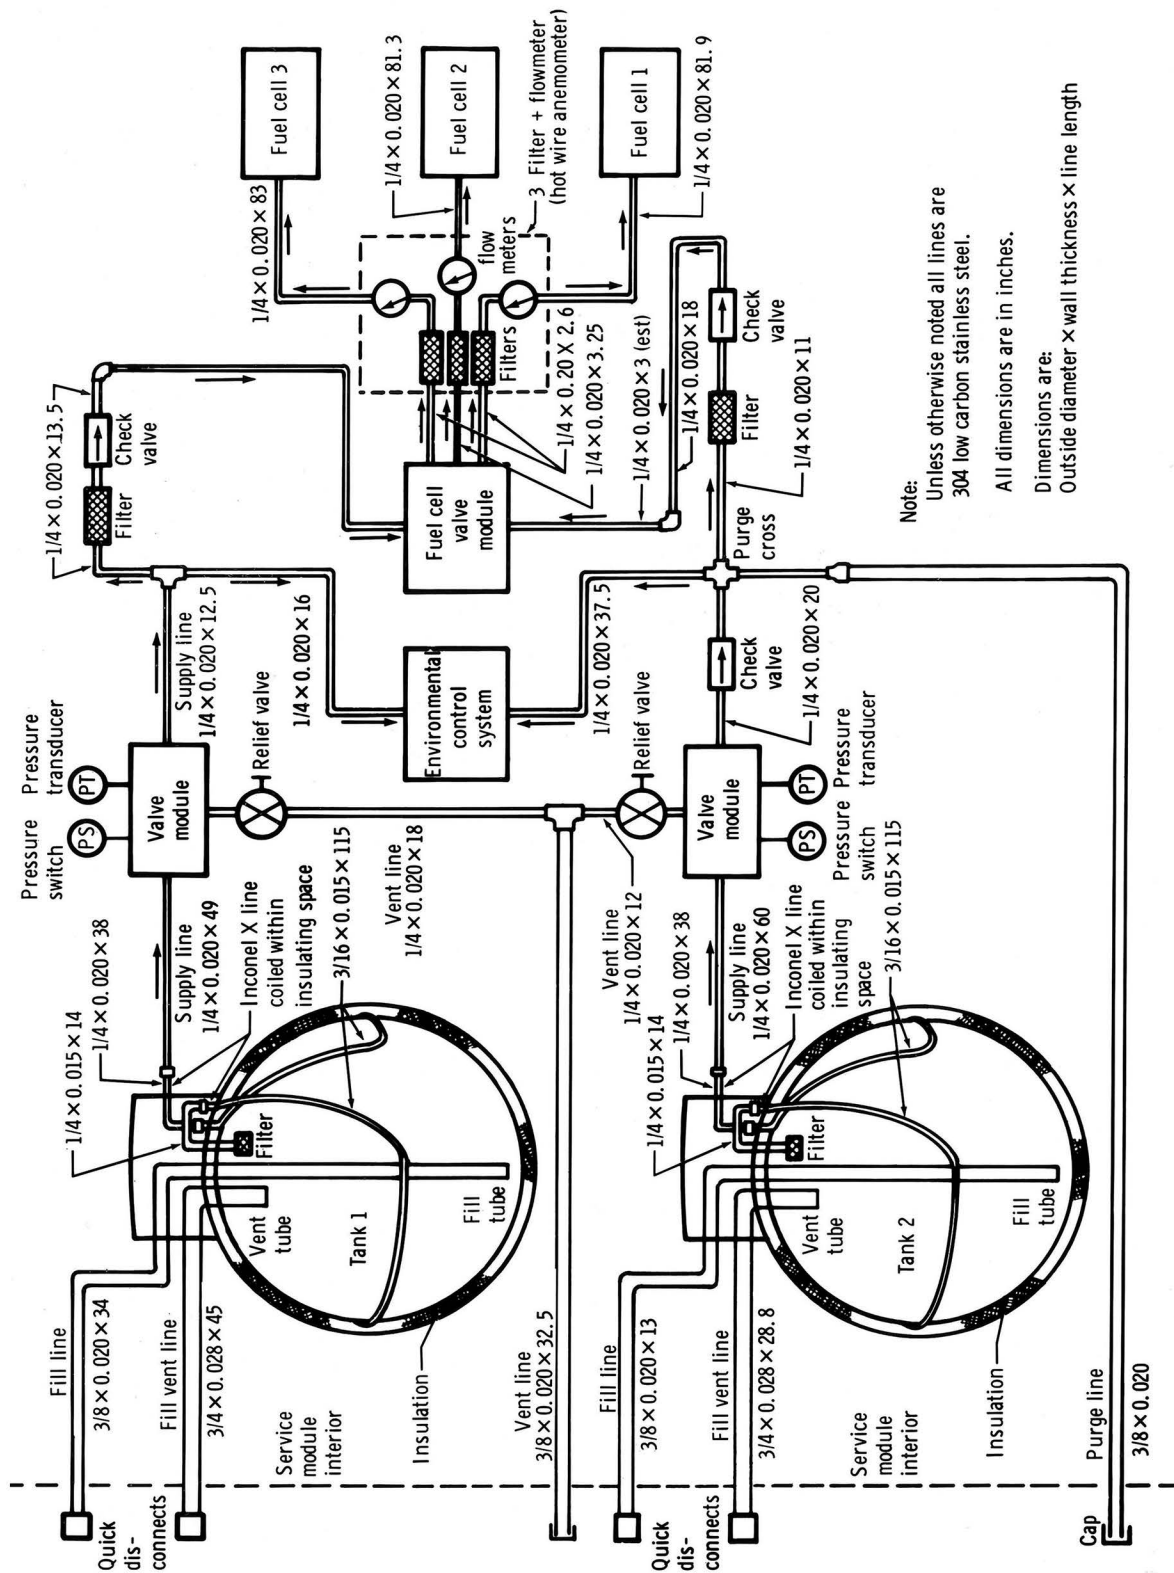
Figure B7-4.- Oxygen system.

The location of the oxygen tank pressure measuring instrumentation is shown schematically in figure B7-4. Pressure transducers for both tanks are located in a valve module assembly along with the pressure switches and pressure relief valves as shown in figure B7-5. The valve module assembly is connected to the oxygen tanks by 19-foot lengths of 1/4-inch and 3/16-inch OD tubing.

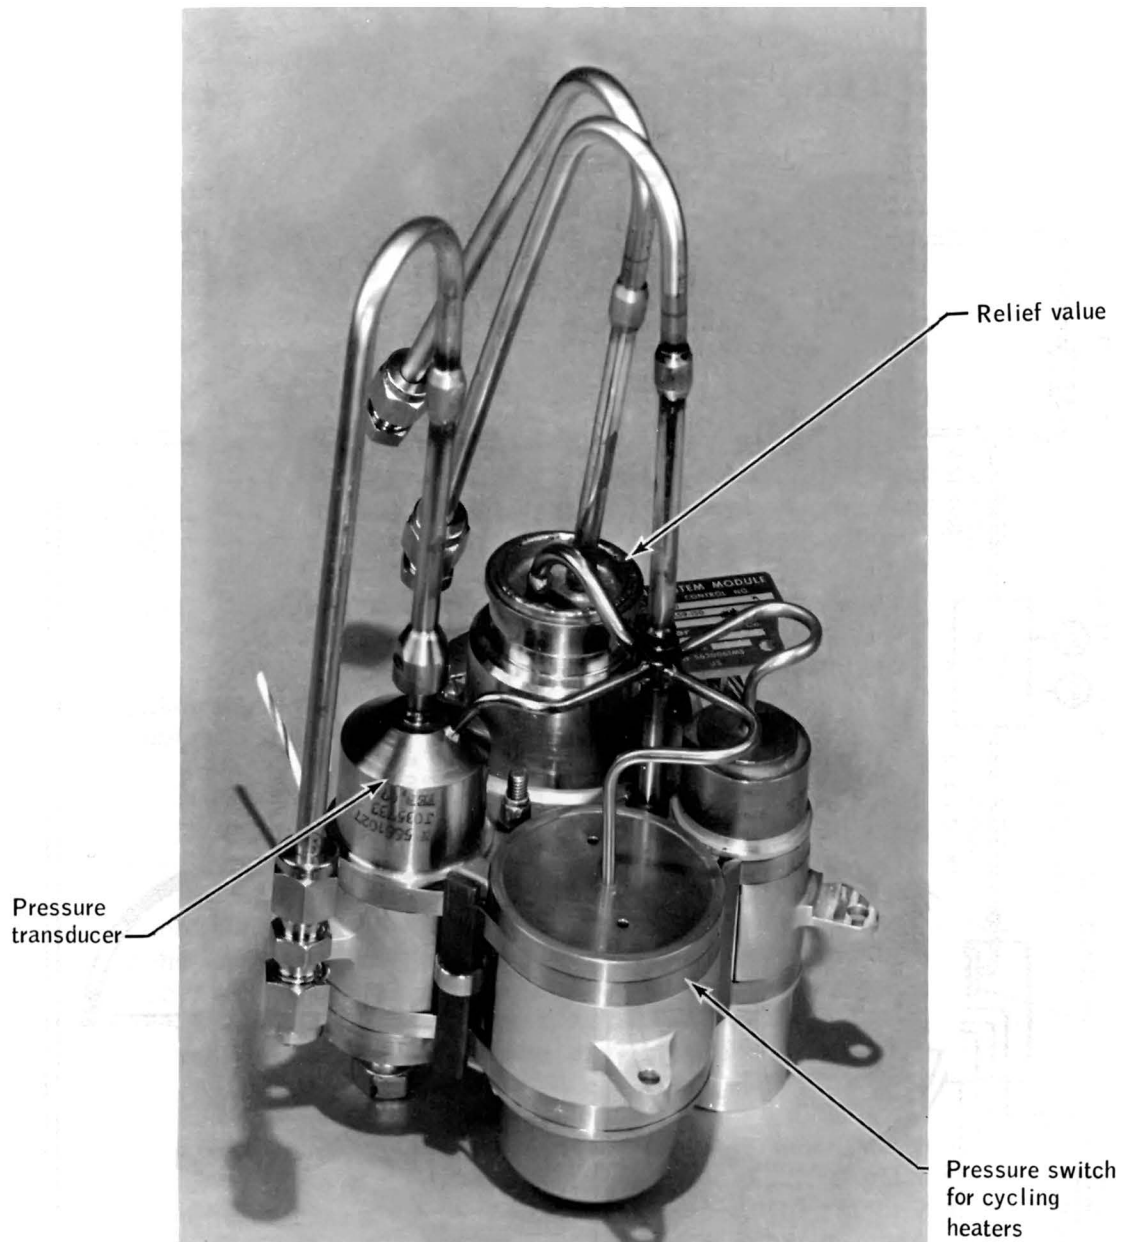
Figure B7-5.- Pressure transducer, relief valve, and pressure switch.

The pressure transducer consists of a diaphragm 0.2 inch in diameter and 0.015 inch thick to which are attached 4 chips of strain-sensitive semi-conductor materials electrically connected into a bridge circuit. When pressure is applied, deflection of the diaphragm changes the electrical resistance of the semi-conductor clips to unbalance the bridge and develop an electrical output proportional to the applied pressure. This output is amplified so that full-scale pressure of 1050 psia gives a 5 V dc output which is indicated on the CM instrument panel and telemetered to the ground through the PCM telemetry system.

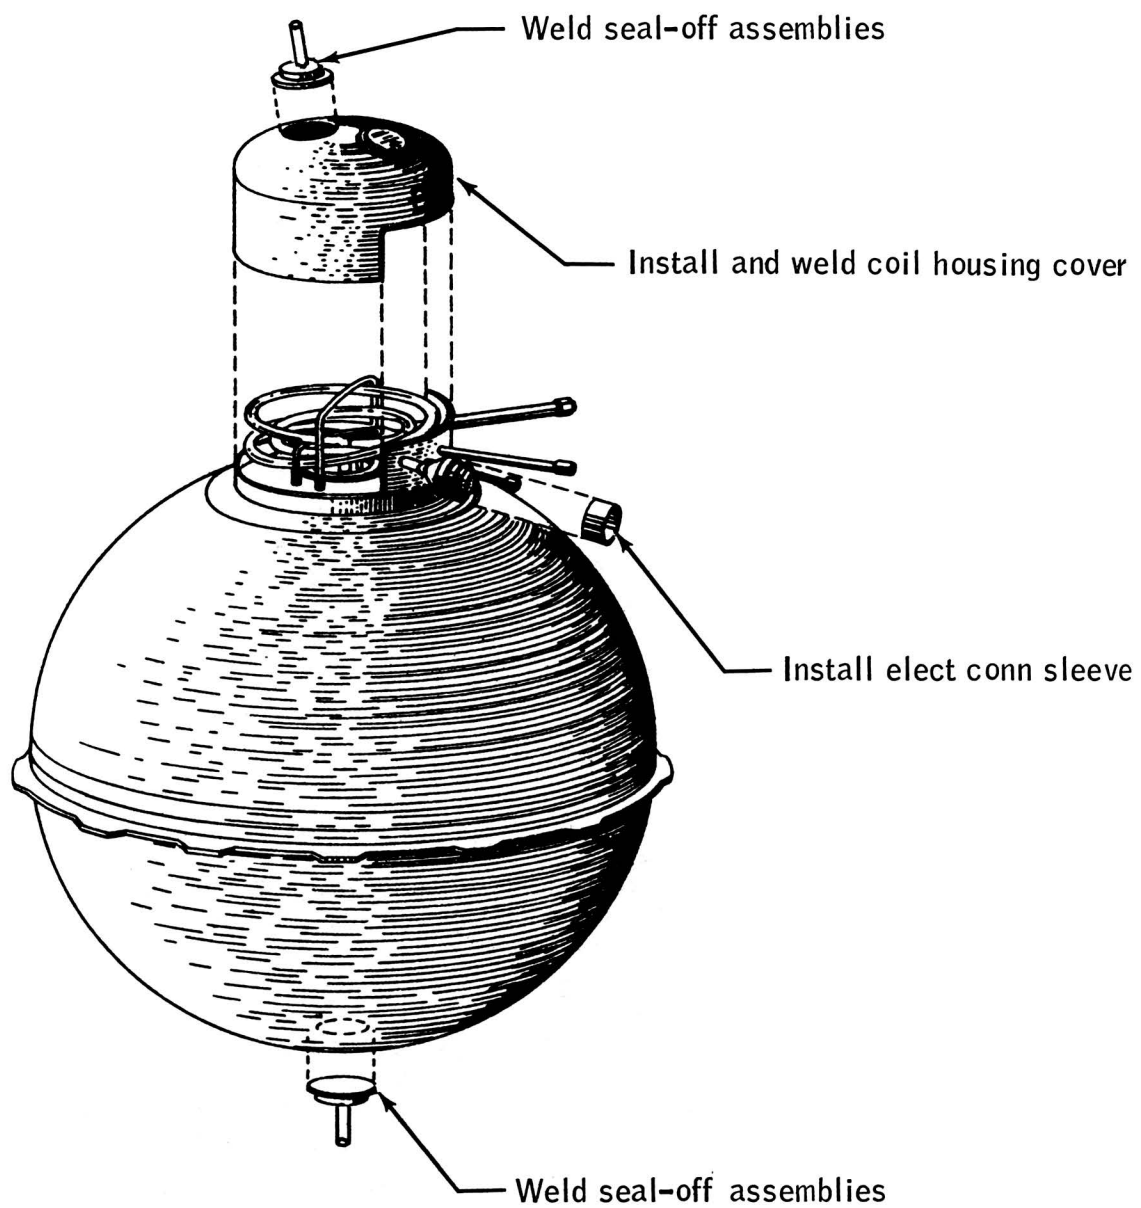
Figure C4-47.- Final vacuum closure operations.

The coil housing (dome) cover is now welded in place. The housing contains the vacuum pumpdown tube, the blowout disc, and the vac-ion pump bracket (fig. C4-47). In addition, a pumpdown tube is welded to the lower hemisphere to speed the pumping process. After the welds are X-rayed, a preliminary pumpdown is made.

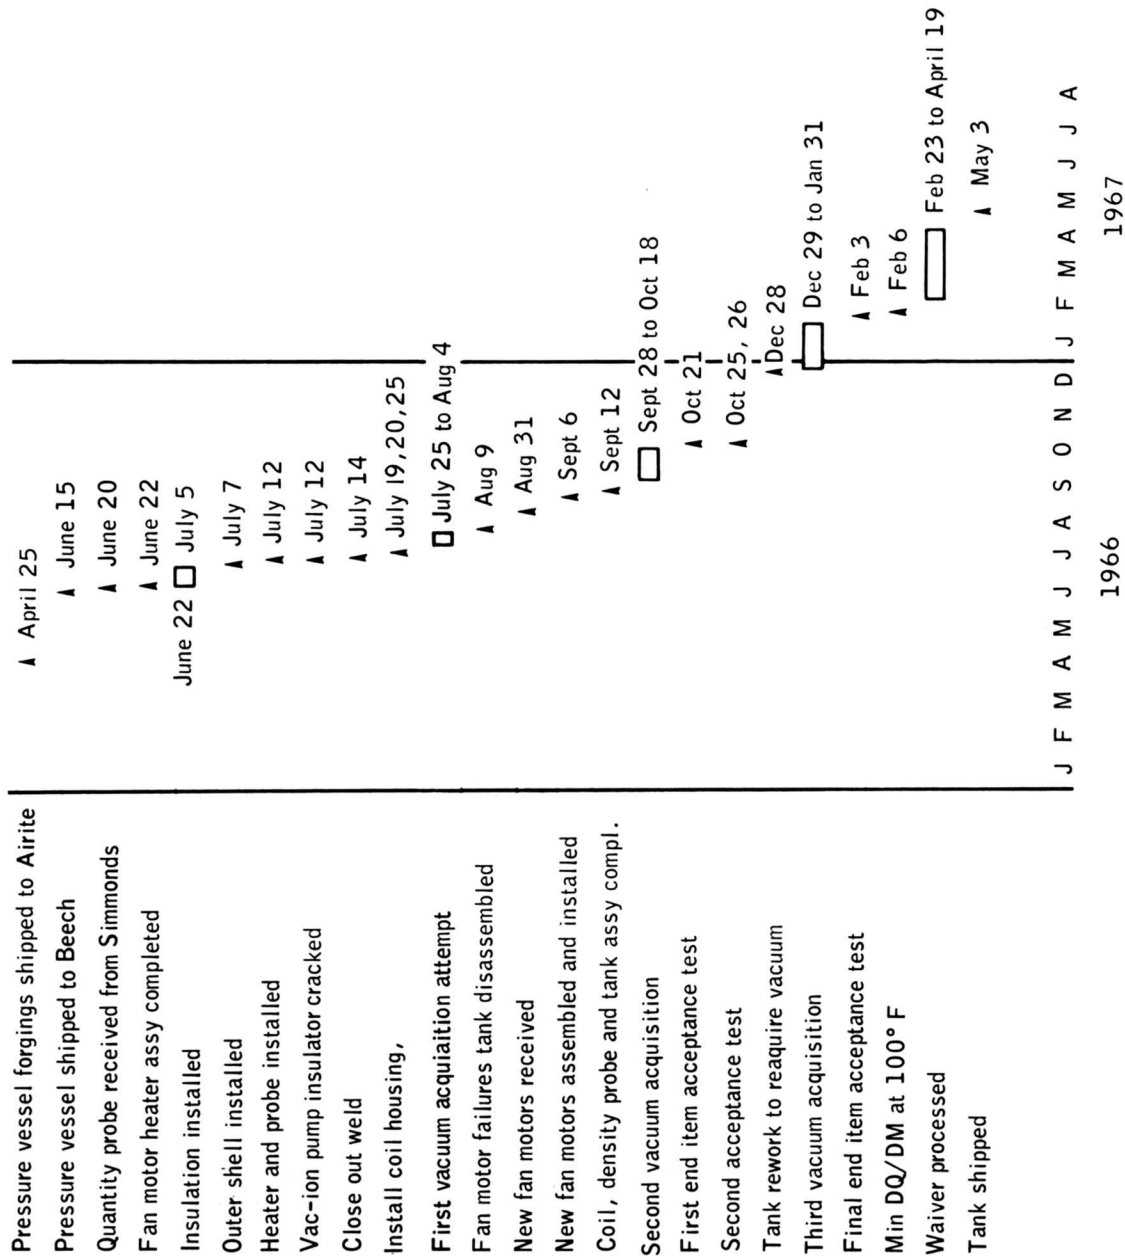
Figure C4-48.- Manufacturing and test flow for the oxygen tank at Beech.

The manufacturing and test flow for cryogenic oxygen storage tank serial no. 10024XTA0008 is shown in figure C4-48. The item of particular significance is the recycle that was required in the manufacturing process brought on by motor failures.

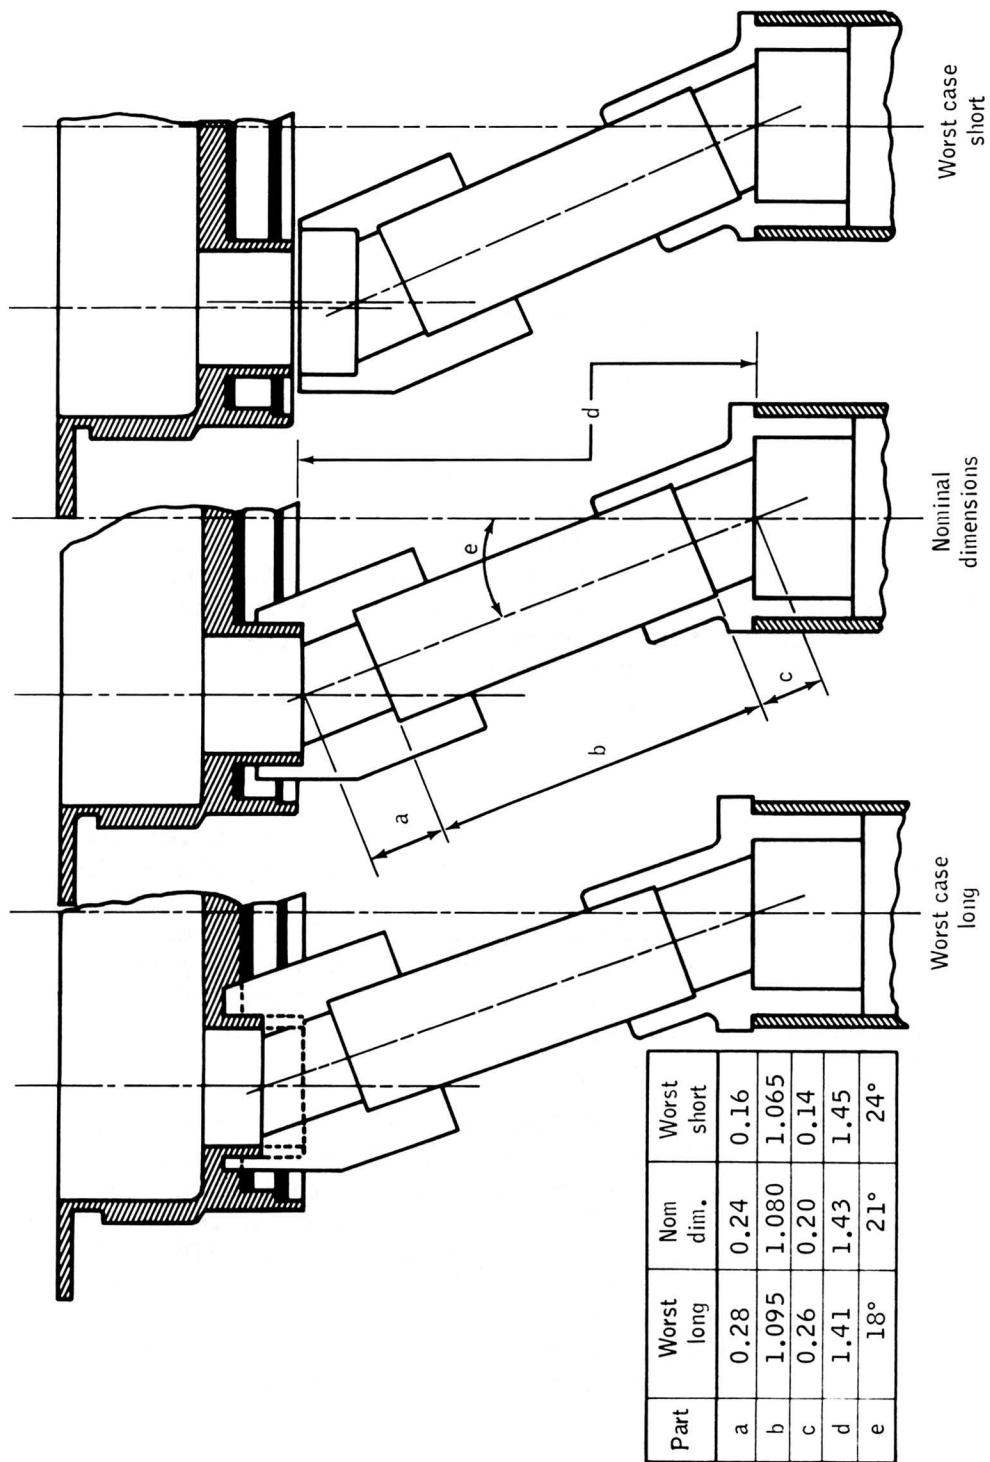
Figure C4-49.- Extreme and nominal tolerance cases for fill tube connection parts.

In addition to the tolerance condition that can exist for the fill tube connecting parts, the center tube of the quantity probe could move downward due to Teflon cold flow. The center tube is supported in the axial position by two Teflon bushings installed in the center tube and a semi-tubular rivet. Prolonged heating, such as the vacuum pumpdown cycles (three cycles for this tank assembly resulting in a total of 1532 hours at 190 to 220° F), could result in the thin walls of the center tube slowly cutting into the Teflon bushings.

Table C4-II shows the range of diametral clearances that can exist at ambient conditions (73° F) and at a typical detanking condition (-278° F, which corresponds to the saturation temperature of liquid oxygen at 40 psia). The fit between the Teflon bushing and the tank adapter fitting can result in a maximum 0.003-inch interference. The only other clearance that results in an interference fit occurs if the minimum size holes are provided where the Teflon bushings slide on the 3/8-inch Inconel tube. Tests at liquid nitrogen temperature (-320° F) indicate that the Teflon is not overstressed and does not crack when subjected to interference fits of this type.

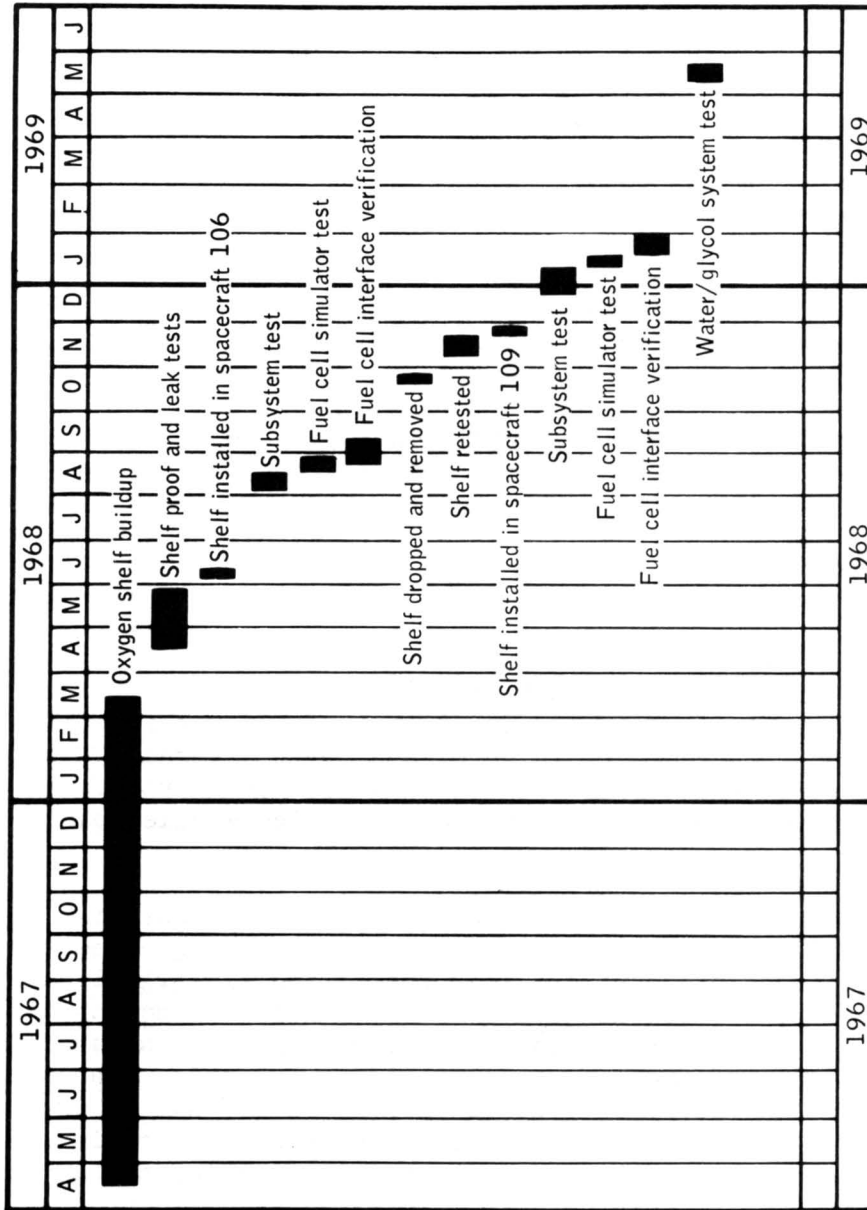
Figure C4-52.- Manufacturing and test flow for the oxygen shelf.

North American Rockwell, Downey, California.- Oxygen storage tank 10024XTA0008 was installed in the no. 2 (outside) position of oxygen shelf S/N 06362AAG3277 at North American Rockwell, Downey, California, soon after receipt in May 1967. Two disposition reports were written during October 1967 to require reheat and reinspection of brazed tubing joints on the oxygen shelf found unacceptable in reading of X-rays. These joints were reheated and accepted. Completion of oxygen tank installation, including tank 10024XTA0009 in the no. 1 position, was accomplished March 11, 1968. Manufacturing and test flow for the oxygen shelf is displayed chronologically in figure C4-52.

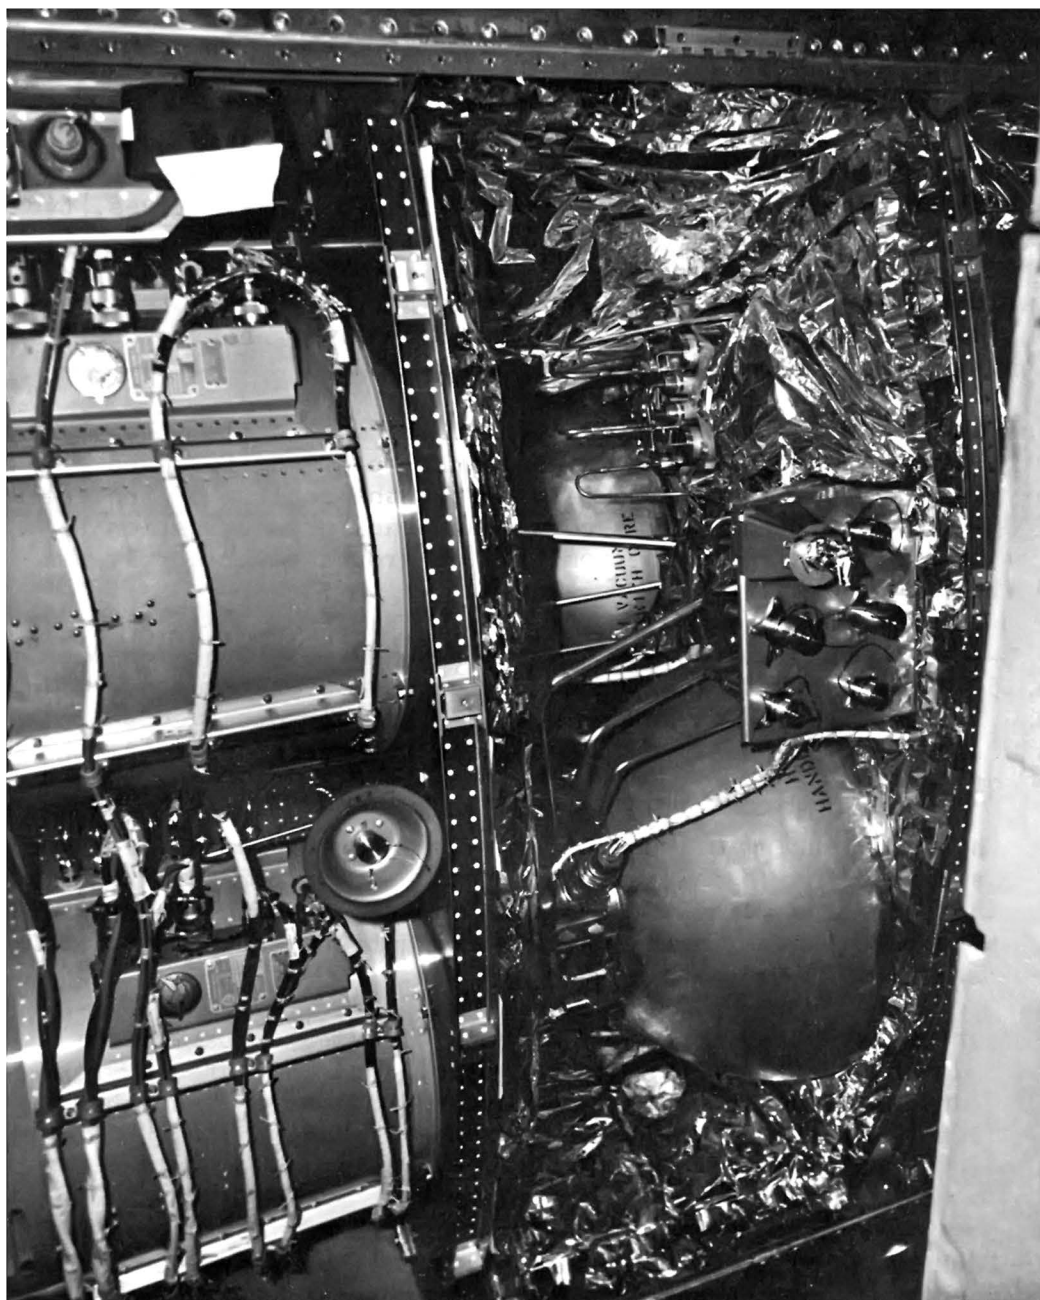
Figure C4-57.- Progress photograph of oxygen shelf taken at KSC  
November 14, 1969

A progress photograph (fig. C4-57) taken at KSC on November 14, 1969, shows the visible condition of the oxygen shelf with tanks, valves, tubing, and cables.

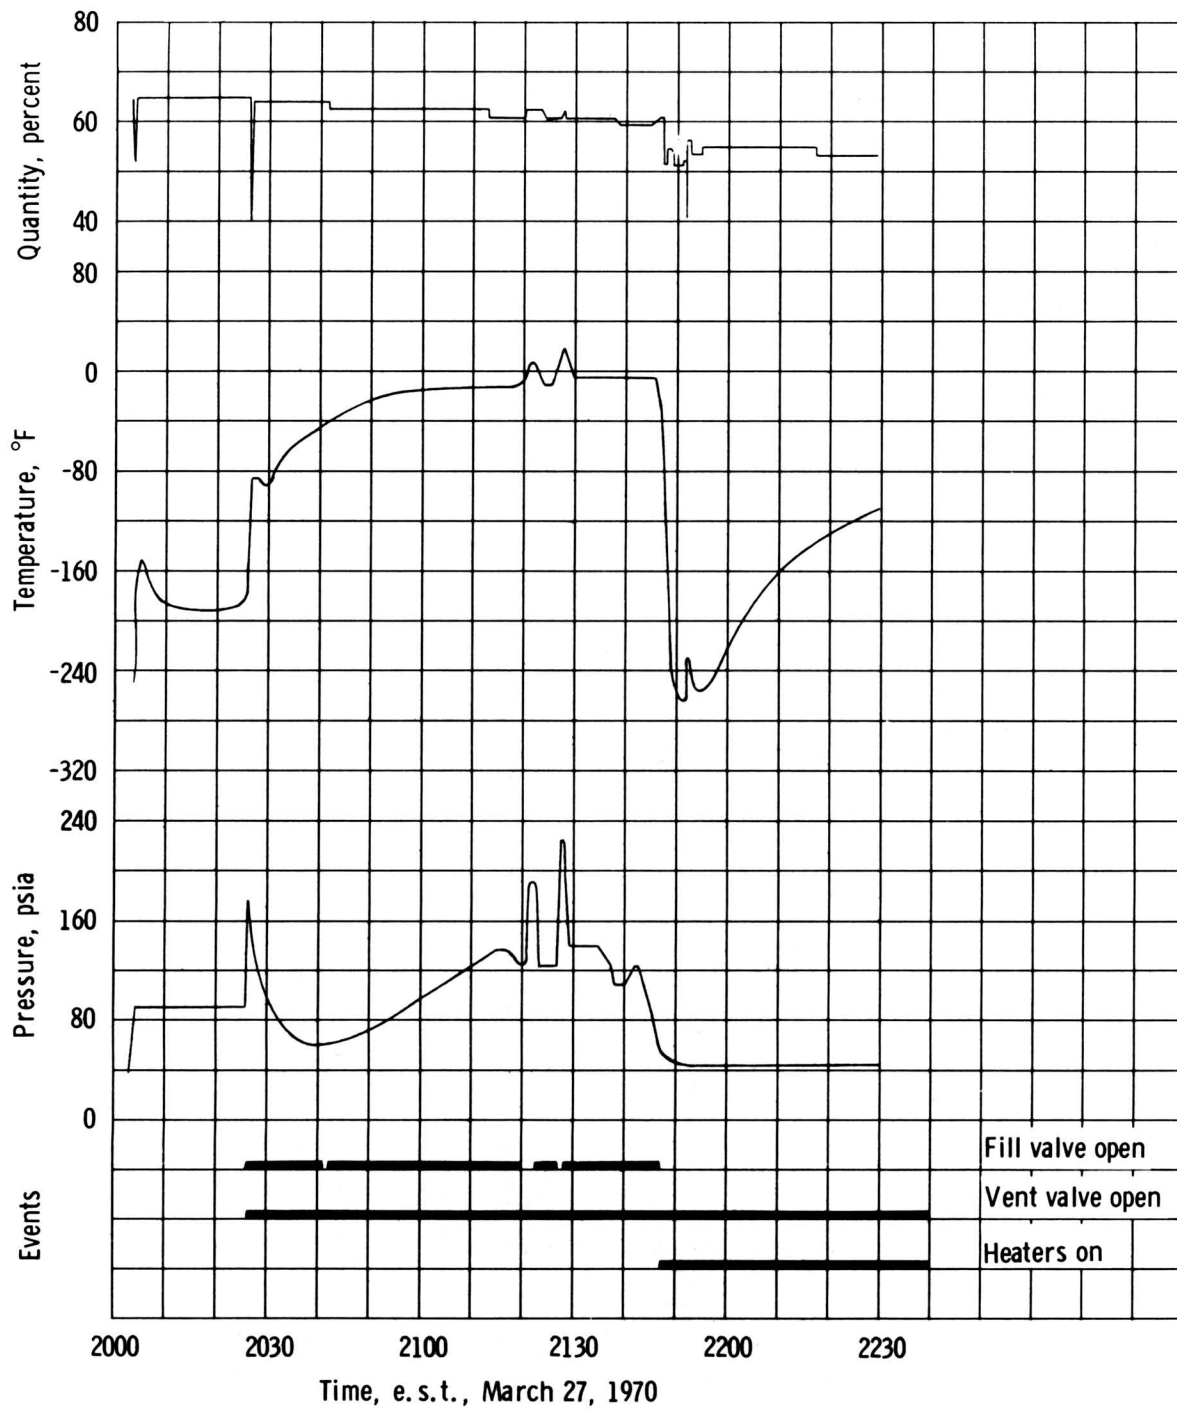
Figure C4-59.- Oxygen detanking attempt using varying purge pressure.

Attempts were made over an 80-minute period to deplete the oxygen content of tank no. 2 by cycling up to various pressures and down, but did not reduce the indicated quantity below 54 percent (fig. C4-59). An attempt was made to expedite oxygen expulsion through the use of the tank heaters operated at maximum voltage and the fans. These were turned on for nearly 6 hours while the vent port remained open (fig. C4-60). Still the indicated quantity remained above 30 percent.

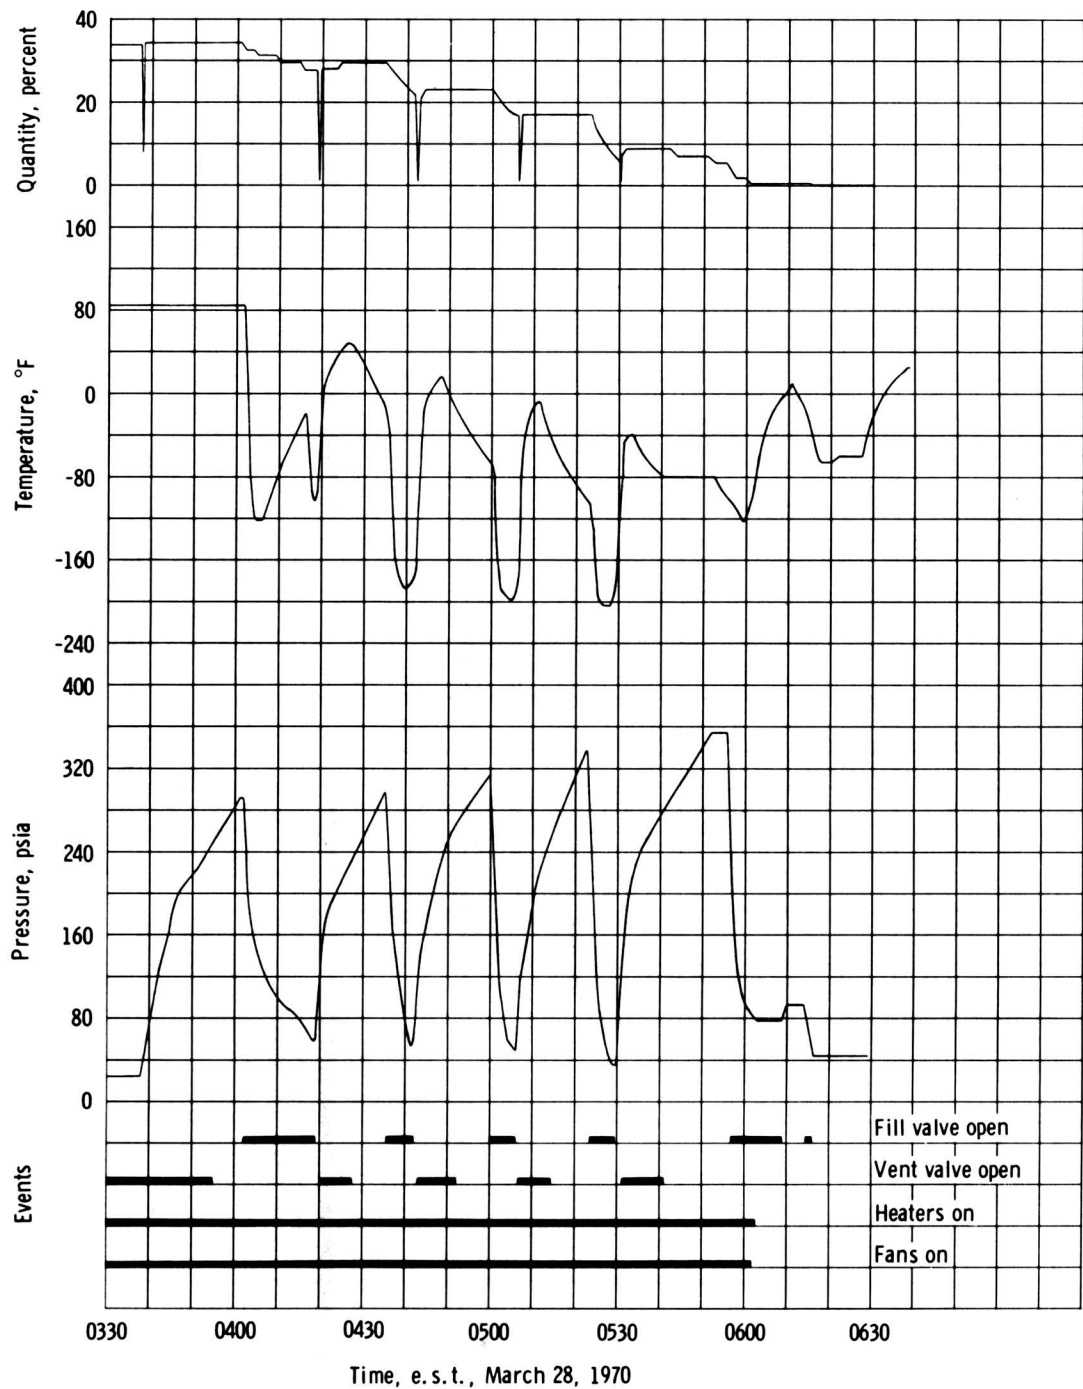
Figure C4-61.- Oxygen detanking using pressure cycles and tank heaters.

Then a pressure cycling technique was employed over a 2-1/2 hour period with maximum power being applied continuously to both tank heaters and fan circuits (fig. C4-61). This technique involved raising the tank pressure by external gaseous oxygen to approximately 300 psia and then opening the fill line to induce rapid boil-off. After five cycles, the oxygen tank quantity indicated zero.

Fan responses were observed to be normal throughout these operations. The temperature sensor on the quantity probe reached its indicating limit (+84° F) halfway through the 6-hour heating period. No observations of whether the heaters cycled on and off were made and subsequent review of the power supply voltage recording showed no indication of heater cycling.

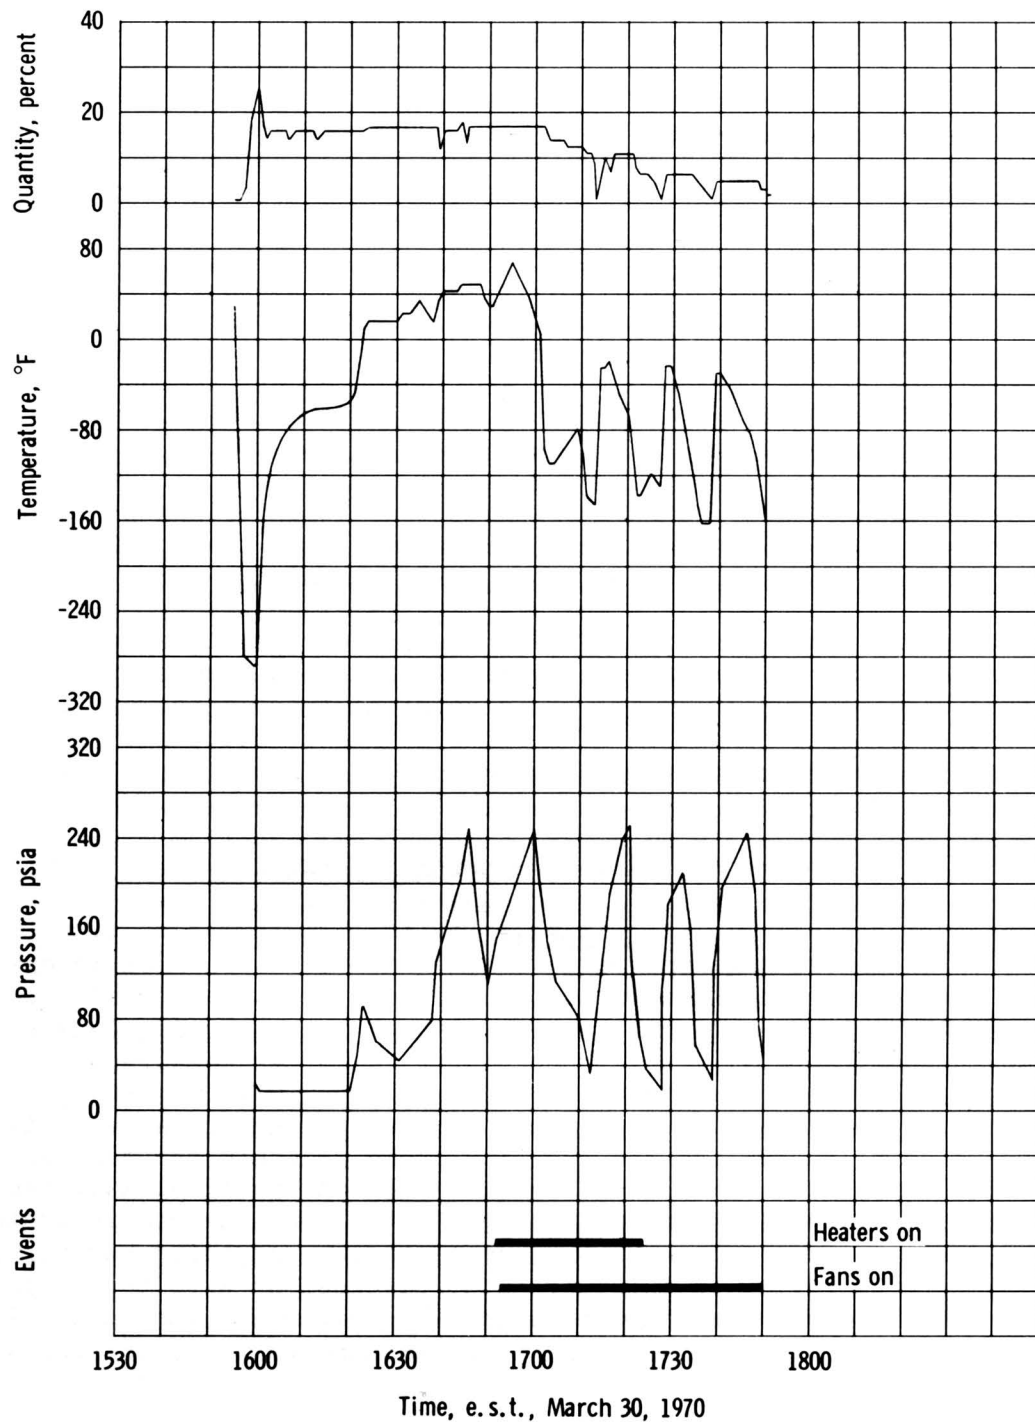
Figure C4-63.- Oxygen detanking using pressure cycles and tank heaters.

To verify this judgment and to assure countdown operability, both tanks were filled on March 30 to about 20 percent in approximately 2.5 minutes. Tank no. 1 detanked normally; tank no. 2 did not. Again the procedure of applying heat at maximum voltage and the cyclic application of gas pressure of approximately 250 psia and then venting was used. Five cycles were applied in a 1-1/4 hour period and tank no. 2 was emptied (fig. C4-63). The fan responses were observed to be normal and no indications of heater cycling were observed.

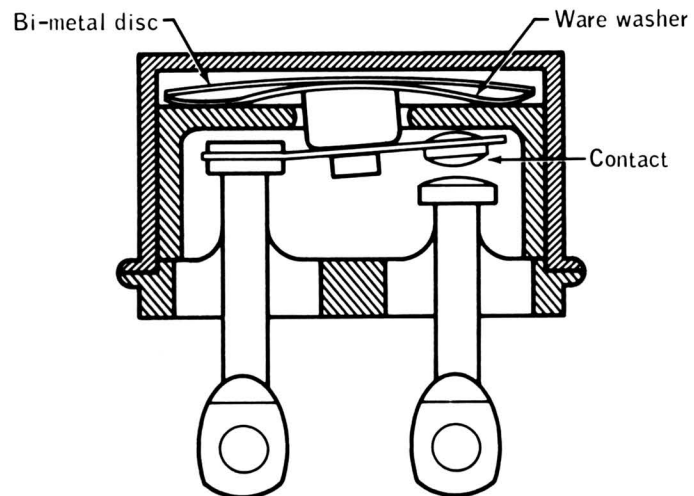
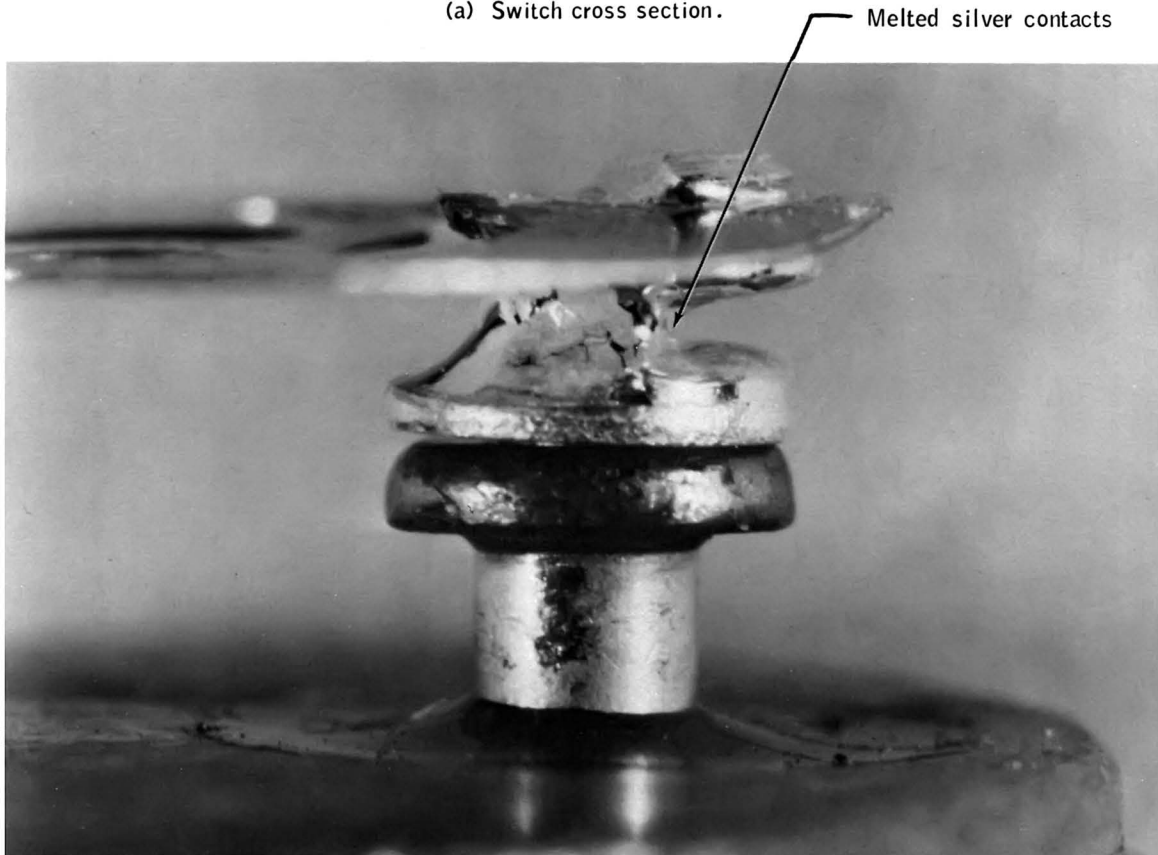
Figure C4-67.- Thermostat configuration and welded contacts.

The test was started and after a few cycles in this mode the previously nonfunctioning (open) thermostat started indicating normal function. At this time it was decided to revert to the originally intended test configuration, i.e., the thermostats directly controlling the heaters. Data from that point on indicated that the thermostats were not cycling the heaters. The heater tube temperature data looked just like the nonthermostat test run. The test terminated at this point and the thermostats were removed and X-rayed. The X-rays indicated that the contact gap was bridged. One thermostat had its case carefully removed to examine the conditions of the contacts (fig. C4-67).

At no time during standard checkout, prelaunch, and launch operations are these thermostats required to interrupt the 65 V dc ground power supply current. As far as could be determined, the special detanking operation was the only time that any thermostats were ever called upon to interrupt this load.

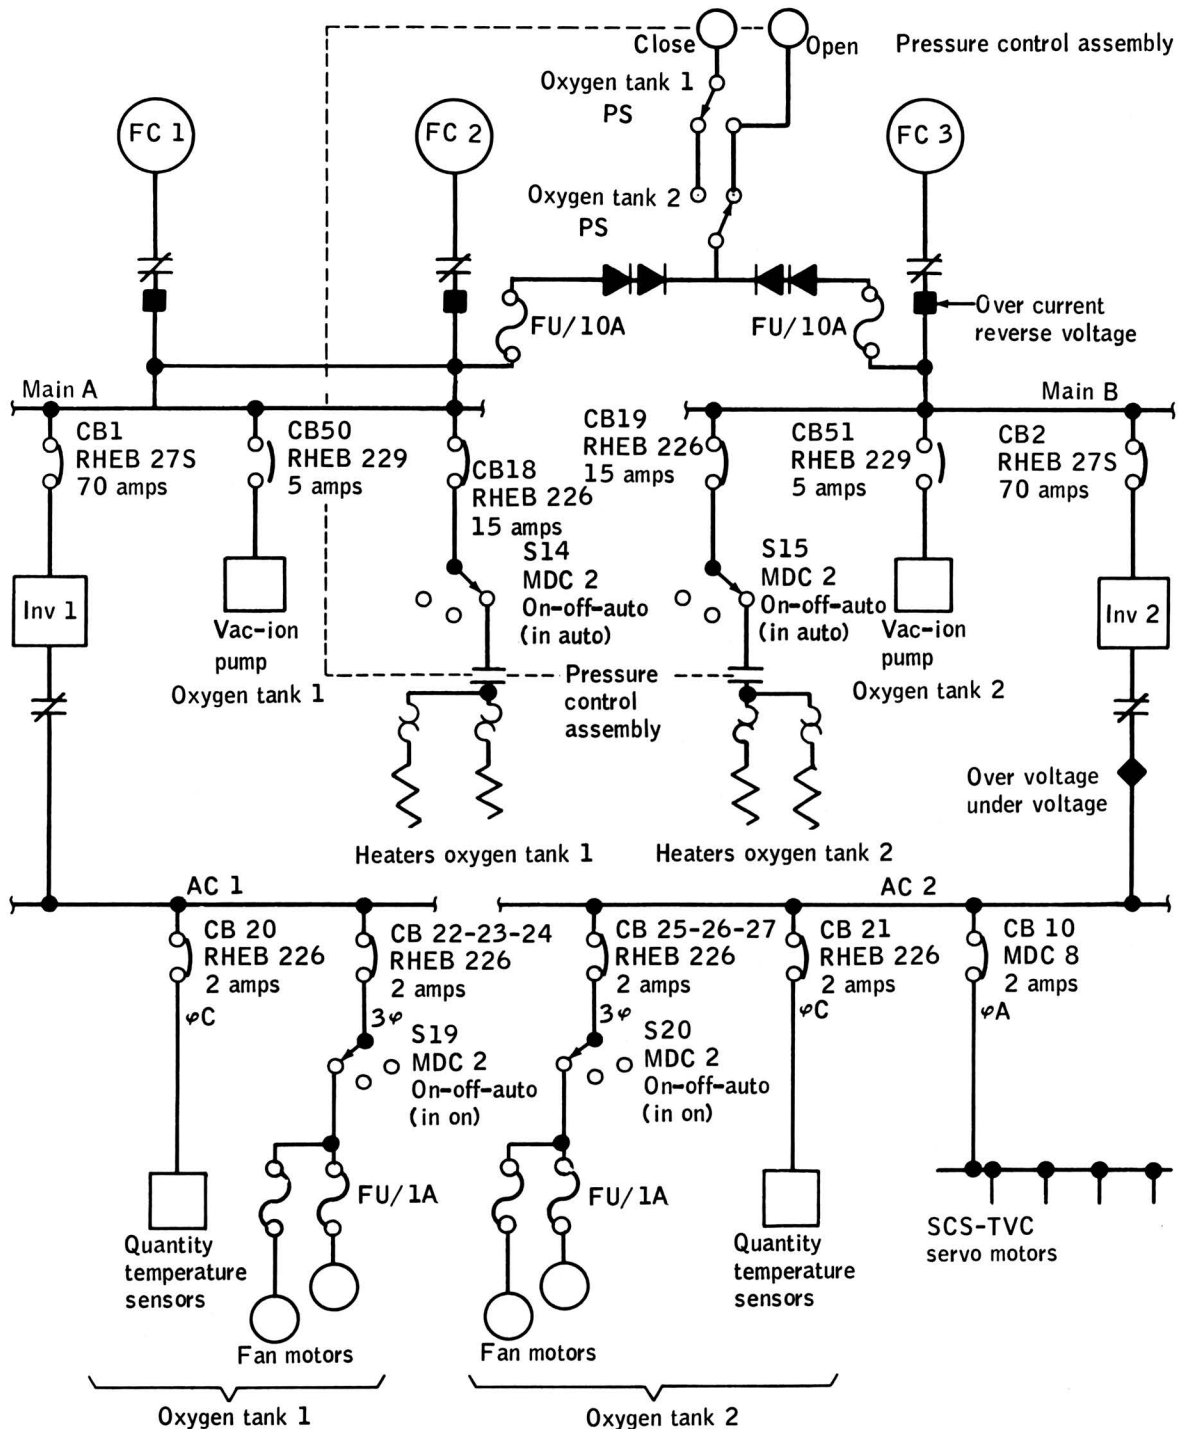
The electrical power system, in general, provides multiple power busses with switching options for selecting an operating configuration. At 55:53:21, the electrical system was configured in accordance with reference 1, as shown in figure D3-5, with fuel cells 1 and 2 connected to main bus A and fuel cell 3 connected to main bus B. Inverter 1 was connected to main bus A and powering ac bus 1. Inverter 2 was connected to main bus B and powering ac bus 2. Inverter 3 was not connected. Battery busses A and B were not connected to main bus A or B. The switches controlling heater operation for both oxygen tanks were in the "auto-matic" position, controlling heater operation through the pressure control assembly. Pressures in the oxygen tanks were at levels which did not demand operation of the heaters. Temperature and quantity sensors on oxygen tank no. 2 were energized from ac bus 2. The quantity gage

Figure D3-5.- Electrical schematic of relevant portions of electrical power system at 55:53:21.

had remained off-scale high from 46:40:06, indicating a probable short circuit either on the leads or the probe assembly. Operation of the fan motors in the oxygen tanks was accomplished throughout the mission using manual control in lieu of the automatic operation afforded by the logic of the pressure control assembly. A routine operation of the fans was requested by the ground at 55:52:58 and acknowledged by the crew at 55:53:06. Energizing of the fans in oxygen tank no. 1 is confirmed by a drop in voltage of ac bus 1 and an increase in total fuel cell current at 55:53:18. Energizing of the fans in oxygen tank no. 2 is confirmed by a drop in voltage of ac bus 2 and an increase in total fuel cell current at 55:53:20. Data substantiating operation and operation times are presented in Appendix B.

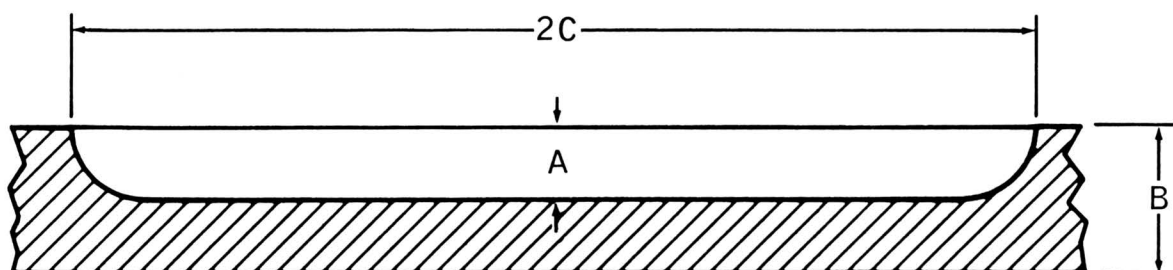
The proof test is the last, and should be the best, flaw detection procedure applied to a pressure vessel. Ideally, the proof test should cause failure if there are any flaws present that could grow to a critical size during subsequent pressurization. For the oxygen tanks in question, a fracture mechanics analysis cannot be made to assess the adequacy of the proof test because of the high toughness of the material and the thin sections used. These factors in themselves, of course, contribute to the confidence that can be placed in the integrity of the pressure vessel and, as discussed in the previous section, essentially rule out the possibility of brittle failure. However, it is worthwhile to estimate the effectiveness of the proof test in identifying those pressure vessels which might develop leaks during pressure cycles subsequent to proof. The failure model proposed considers the plastic instability fracture of a ligament of material produced by incomplete fusion during electron beam welding. The main features of this model are illustrated in figure D3-9. It essentially represents a long flaw in the tank wall at the

Area of lack of fusion produces  
an effective crack of depth  $A$   
& length  $2C$  in tank wall of  
thickness  $B$ .  $2C \gg A$

Figure D3-9.- Ligament model for ductile fracture of pressure vessel.

equatorial weld. It is postulated that the ligament will fail when its stress reaches the tensile strength of the material. Calculations show that the ligament stress  $\sigma_l$  is related to the average wall stress

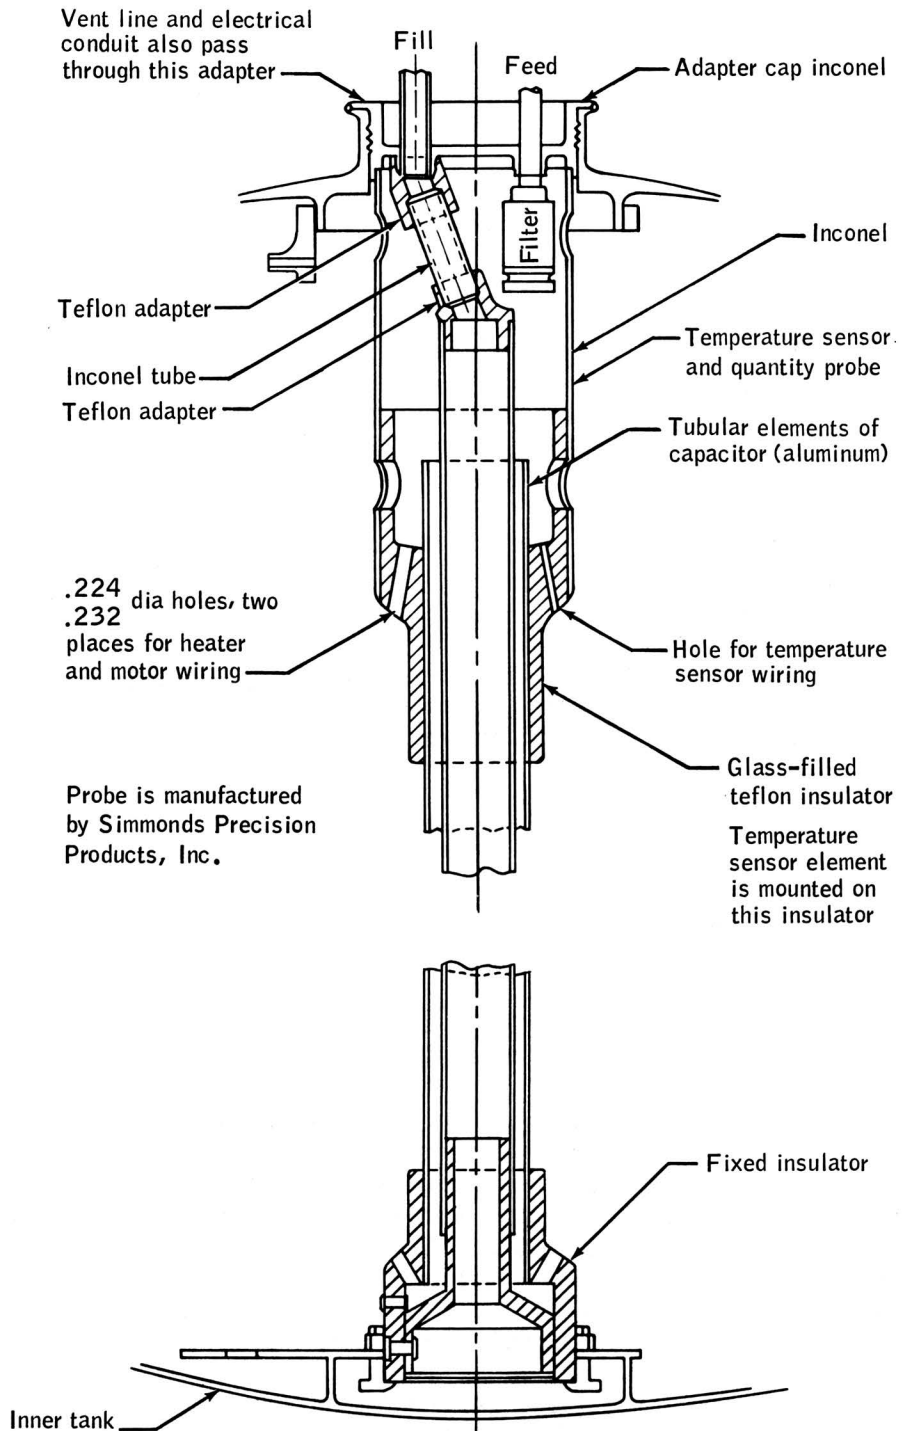
The quantity gage capacitor (fig. D3-12) consists of two concentric aluminum tubes which are adequately mounted and supported. The inner tube of the capacitor constitutes the extension of the fill line. The outer tube is perforated to insure access of the oxygen to the space between the capacitor plates. The relative position of the two plates is maintained by insulating Teflon separators. Shorting of the capacitor at the plates within the tank requires bridging of the gap between the tubes by a conductive material. Shorting could also be induced by the contact of bare lead wires resulting from insulation damage. The power input to the quantity gage is regulated and limited by the high impedance source of the signal conditioner. The spark that could be

Figure D3-12.- Quantity gage.

generated is at the 7- to 10-millijoule level. The evidence provided by the data can be construed to indicate that the effects of the probe failure during flight were limited to data loss.
