# **REPORT OF APOLLO 13 REVIEW BOARD**

**APPENDIX B - REPORT OF MISSION  
EVENTS PANEL**

**APPENDIX C - REPORT OF MANUFACTURING  
AND TEST PANEL**

**APPENDIX D - REPORT OF DESIGN PANEL**

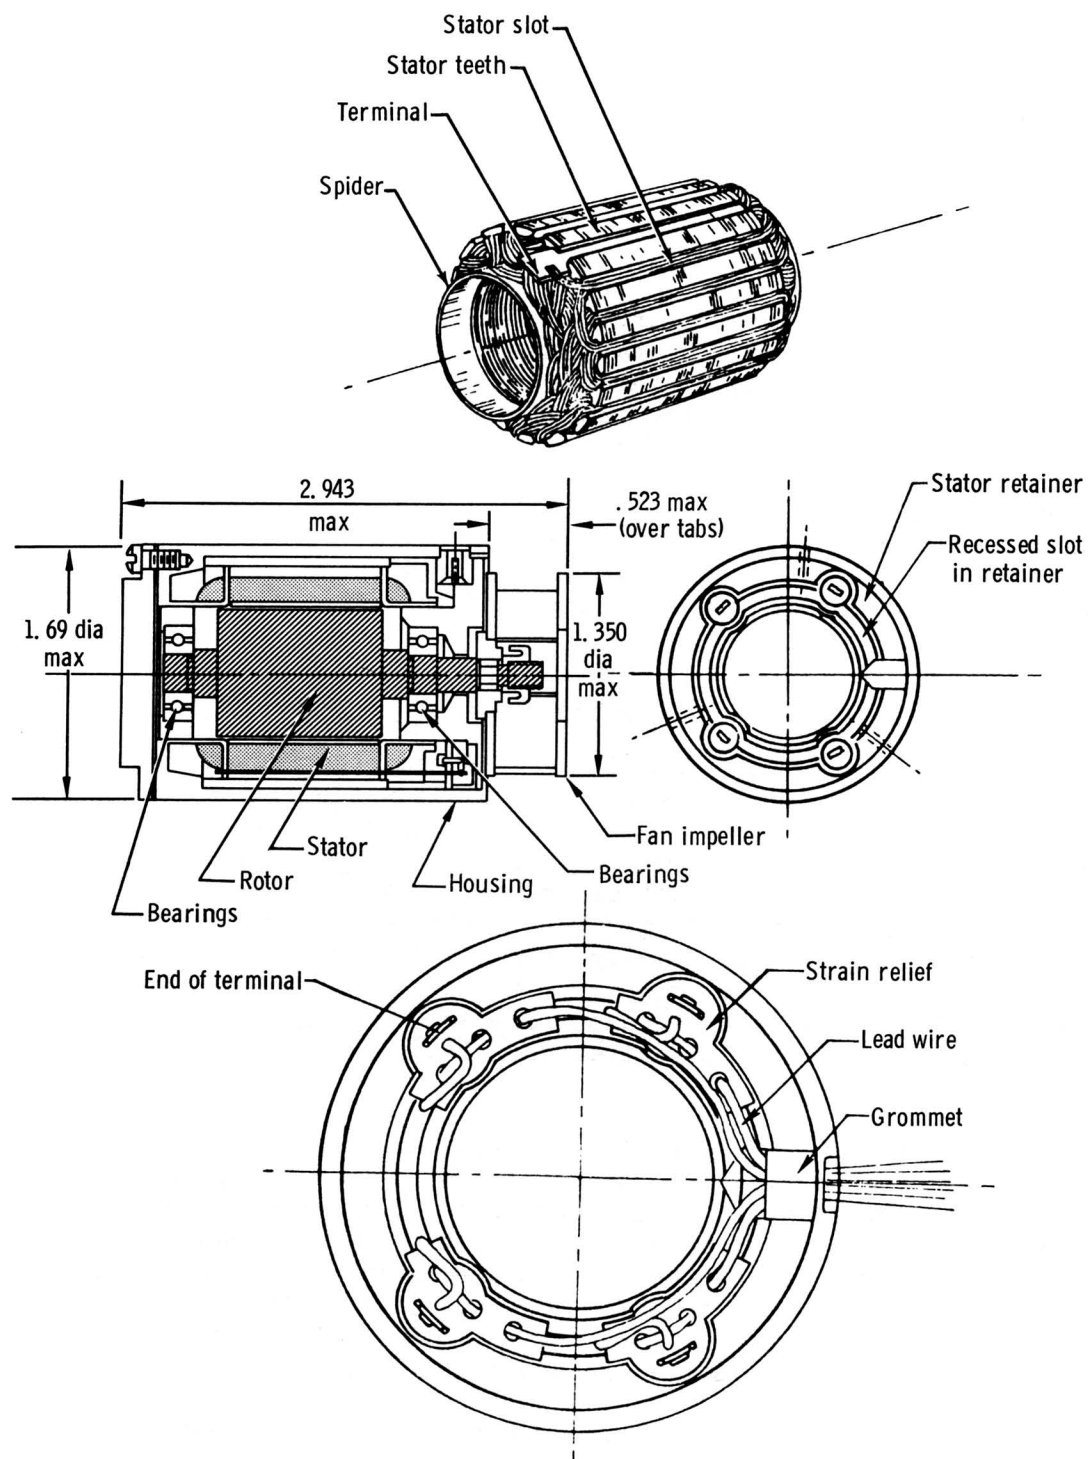
The stator windings are fabricated with number 36 American Wire Gage (AWG) wire, using a Teflon-coated ceramic insulation. The ceramic insulation is brittle and subject to breakage if proper tension is not used in fabricating windings or if sharp bends are made at the winding

Figure D3-15.- Oxygen fan motor.

end turns. Acceptance testing of the wire is conducted on the first 100 feet of each reel. The wire is considered acceptable if no more than 10 breaks in insulation are exhibited in the sample when pulled through mercury at 25 feet per minute. The rejection rate for stator winding faults for motors processed early in the production run was substantial. Improved yield was achieved only by rigid adherence to the winding tension process control used in fabricating the windings, proper assembly techniques, and frequent in-process dielectric testing. Phase-to-phase short circuits or shorted turns within a single phase are more likely than phase-to-ground faults. A limited amount of insulation is provided between windings and ground. Phase-to-phase insulation is limited to the end turns. Considerable improvement was accomplished in the acceptance rate of motors built after the fabrication control techniques were developed (Appendix C). No problem was exhibited in the testing of the two motors finally installed for flight in oxygen tank S/N XTA0008.

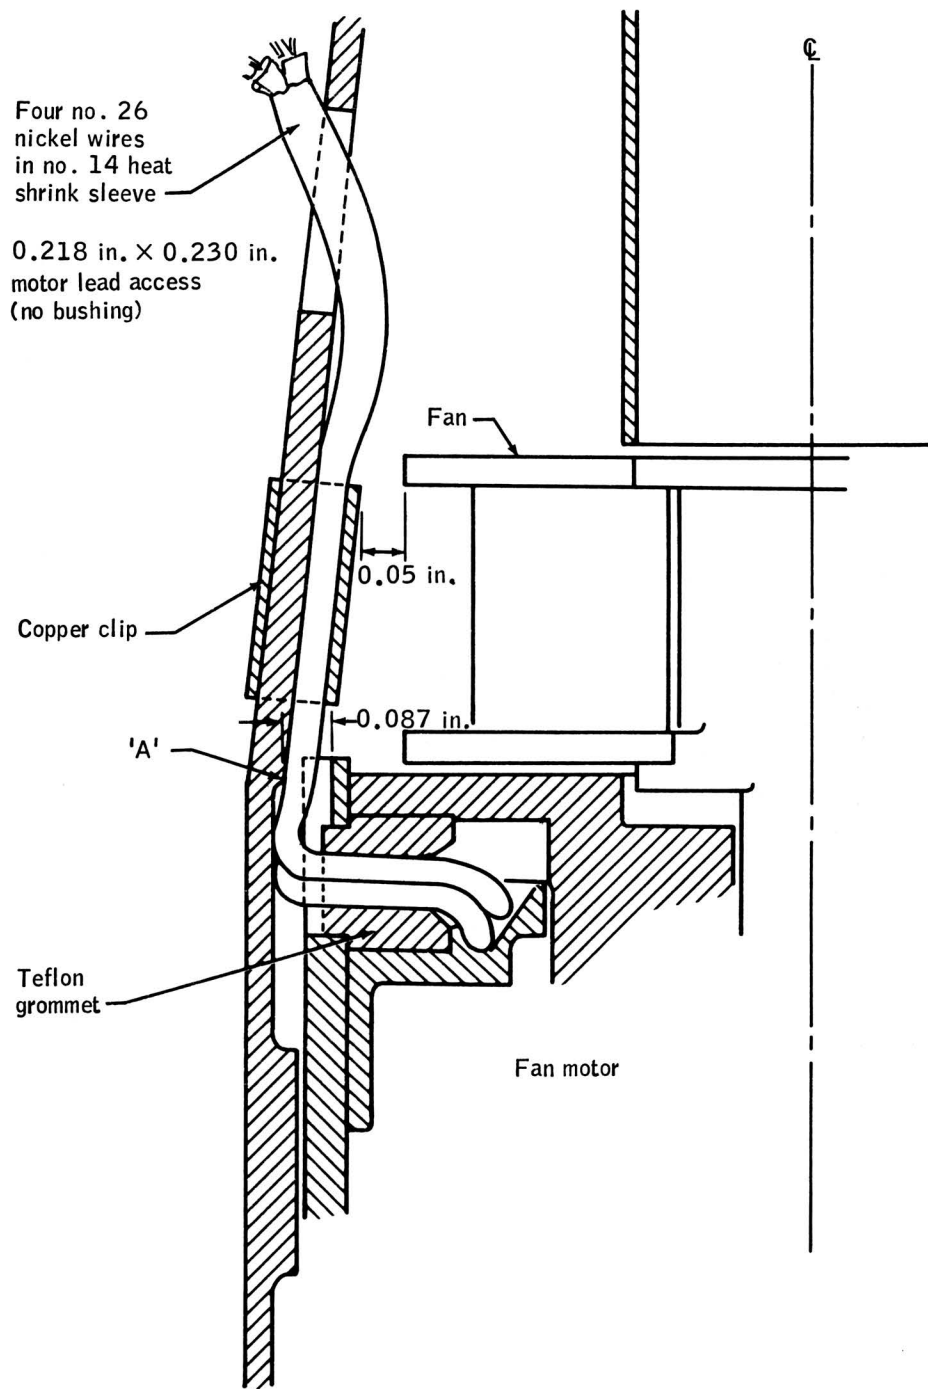
During assembly of the tank, three bundles of six wires each are sequentially pulled through the conduit. The first bundle, consisting of the two quantity gage wires and the four temperature sensor wires, is pulled through the conduit along with the pull wires for the other bundles. The second and third bundles each consist of one set of motor leads encased in 0.012-inch shrink-fit tubing and one set of heater leads. The pull wires have a break-strength of 65 pounds. Since the third bundle of wire must be forceably pulled through the conduit, damage to wires in this bundle or the others may result which may not be detectable without physical inspection. Physical inspection cannot be accomplished with this design.

Figure D3-17.- Typical wire routing for fan motor (four times full size).

The calculated break strength of a number 26 AWG nickel wire is 11 pounds and elongation of 28 percent can be experienced before break. If the number 26 AWG wires do not share the load associated with pulling the bundle through the conduit, damage to the wire(s) will result before the pull wire breaks. Stretching of the wire results in local neck-down of both the conductor and insulation. In subsequent operation of the circuit, the locally smaller gage conductor can produce local hot spots and progressive deterioration of the insulation.

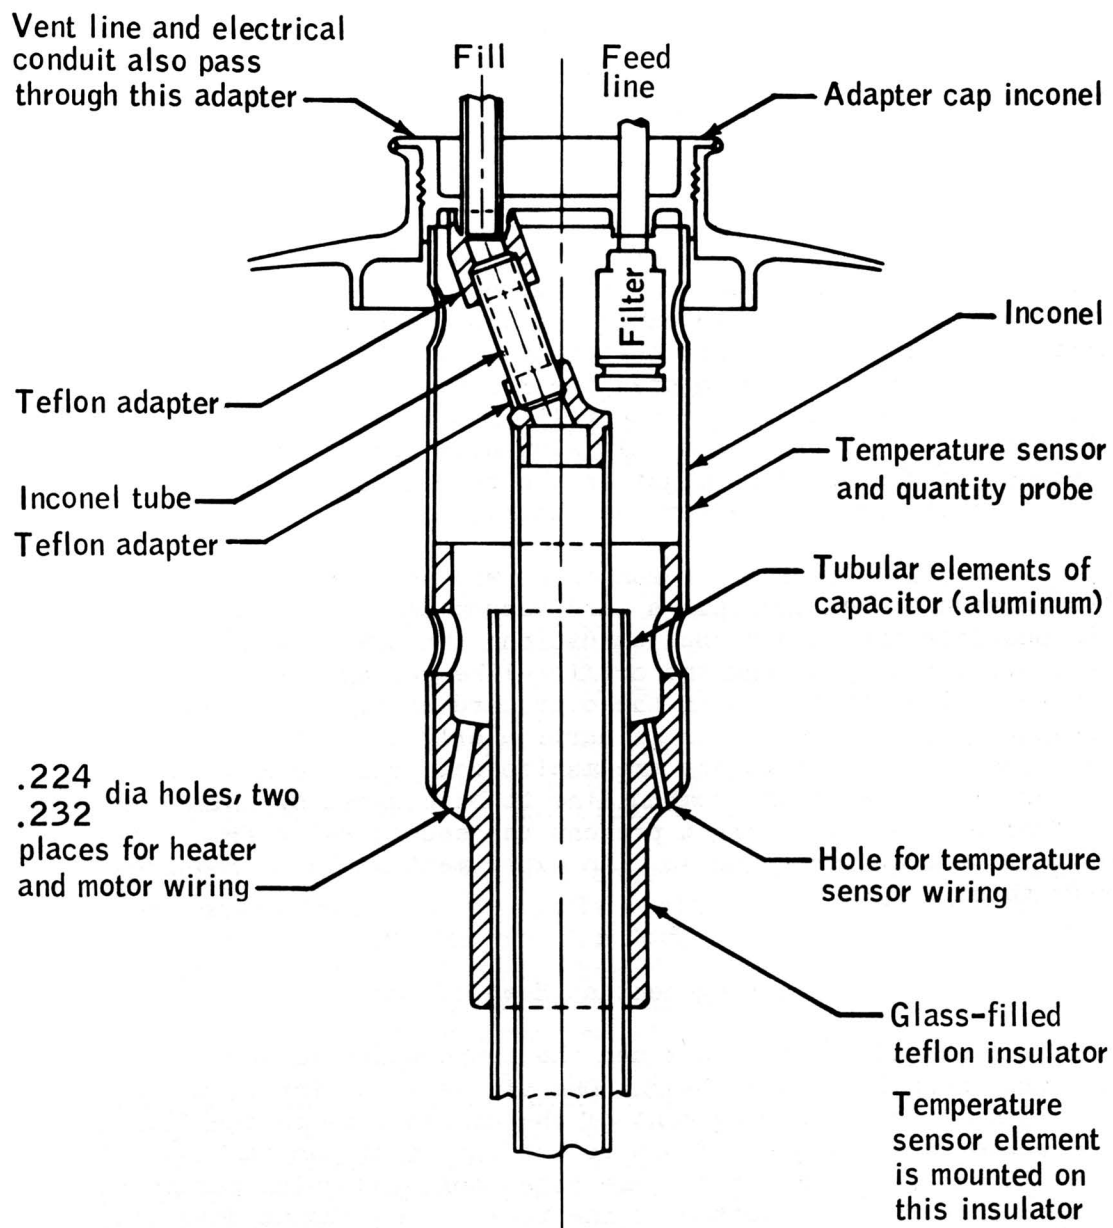
The head ends of the tank and the temperature sensor and quantity probe are shown in figure D3-18. One of the more significant features of the design is the arrangement of the connections in the fill line which routes the cryogenic fluid to the bottom of the tank, via the inner element of the quantity gage capacitor, and which permit the fluid to flow from the bottom of the tank during ground detanking. The manufacturing drawings of the elements of this connection, two Teflon adapters and an Inconel tube, allow a tolerance stack which is excessive. One combined worst case results in a connection which cannot reach from the fill tube connection in the tank head to the center element of the quantity gage capacitor. The other results in a connection length which prevents assembly of the probe to the adapter in the head of the tank. These are shown in figure D3-19. The tolerances on concentricity between the inner element of the capacitor and the outer shell of the probe are not known and are omitted from this figure. Inclusion would show an even worse situation than shown.

Figure D3-18.- Arrangement of head end of tank.

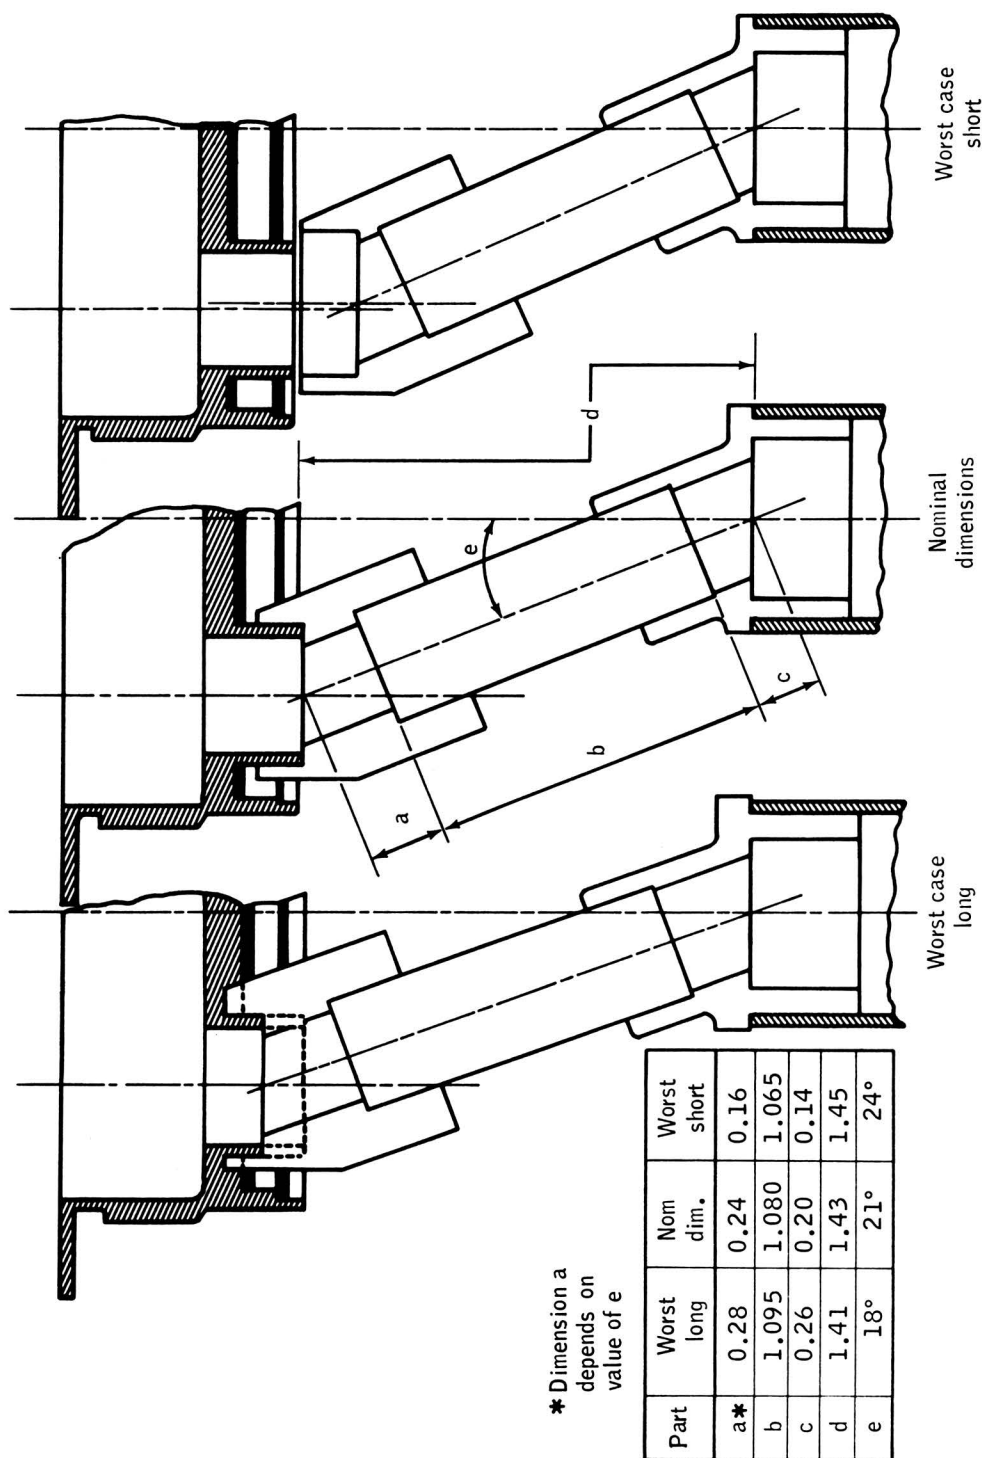
Figure D3-19.- Possible variations in fill line connection.

The experience with the oxygen tank no. 2 in Apollo 13 (apparently normal detanking at Beech, but normal detanking not possible at KSC) suggests that the components used in the fill line connection were close to a worst-case short situation. Tests conducted recently at Beech show that near normal detanking is possible when considerable leakage is present at the joints in the connection, and that a substantial displacement of the top Teflon adapter relative to the fill line in the tank adapter cap is necessary to reproduce the KSC situation.

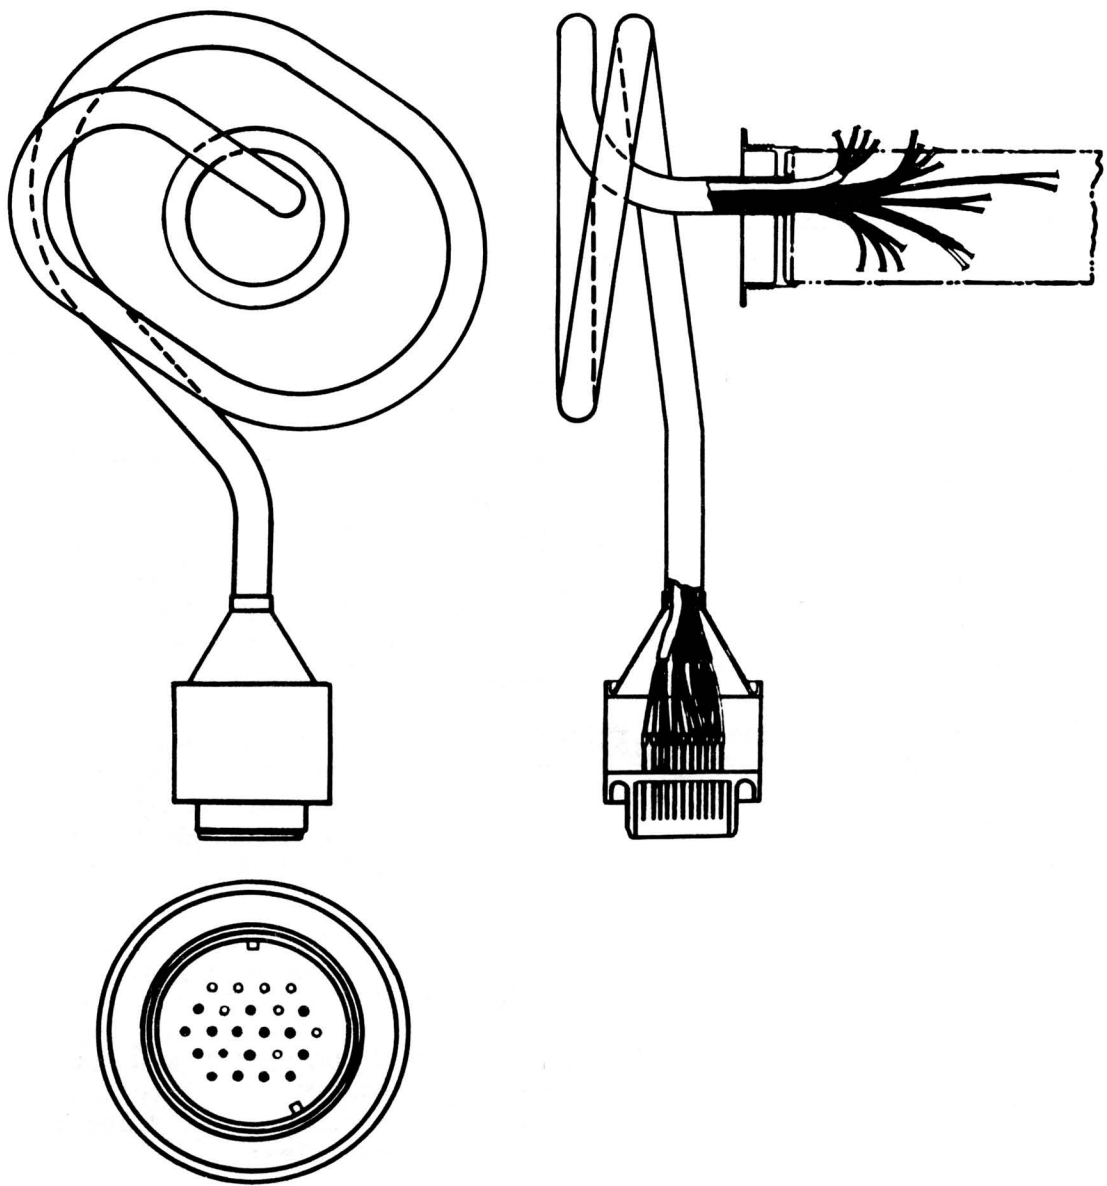
A total of 18 wires pass through the electrical conduit, eight AWG no. 26's, four AWG no. 22's, and six AWG no. 20's. The conduit is shown in figure D3-23. At the start of the investigation some members of the Panel felt that the unorthodox detanking procedure used at KSC could have resulted in unacceptably high temperatures in this electrical conduit due to resistive heating of the heater wires. This possibility is discussed in a later section.

Figure D3-23.- Arrangement of electrical conduit.

The design of this portion of the tank results in a configuration in which it is not possible to perform visual inspection of wiring after assembly. In consequence, the possibility of damage, in many cases undetectable by normal quality assurance procedures, is significant.
